Western Cape Provincial Coastal Access Assessment and Pilot Study

MAIN REPORT

August 2018

Draft for public comment

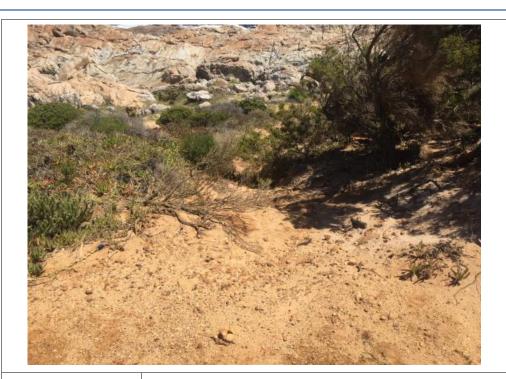
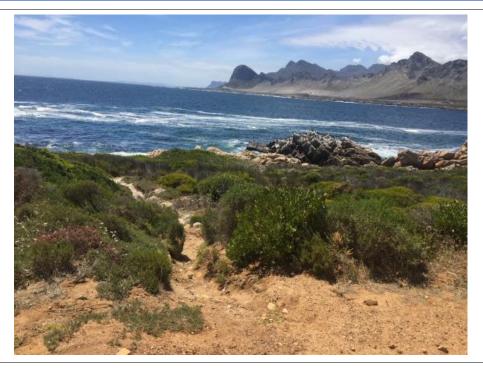
Town/area	Pringle Bay
Site Ref:	Pring 01
Description:	This section of the rocky coastline is accessed via multiple informal pedestrian pathways that lead off several abutting gravel roads and cul-desacs.
	A formal access point to a small beach is provided in the north east of this area.
Facilities provided:	Refuse bins, turning circles, parking, ablutions, signage,
Planned uses catered for:	Viewing, walking, dog walking, surfing, swimming, fishing
Concerns:	Turning circles at smaller cul-de-sacs in the area (e.g. Gull Road) show signs of damage to natural vegetation. There is a proliferation of informal footpaths at some of the informal access points (end of Point Road and northern facing cul-de-sacs). These encroach into the dune vegetation.

Consider formalising some of the key informal access areas in this section where a clear demand is identified by the presence of the many footpaths (e.g. display signage to regulate intended uses and prevent further environmental degradation).

Options to prevent access from the smaller cul-de-sac roads in this section should be investigated. Consider providing an alternative means of access (e.g. boardwalk) in areas where environmental damage is evident. Rehabilitation of environmental damage is required.

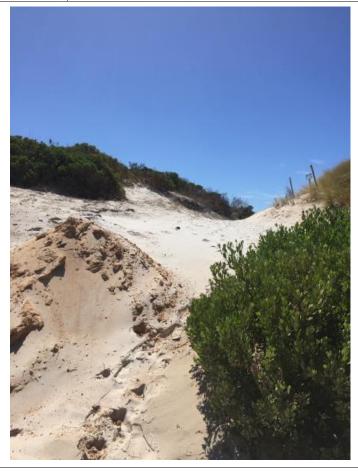
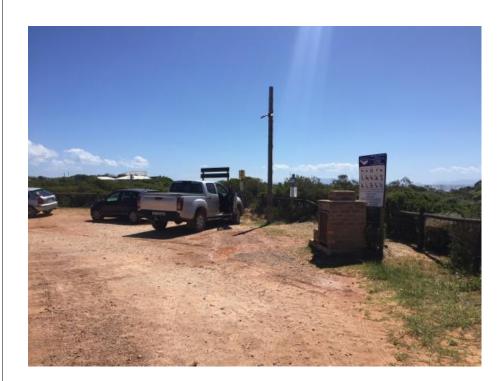
Town/area	Pringle Bay
Site Ref:	Pring 05
Description:	Pedestrian access to the beach is provided via a large sand track over the dune. Dune movement has rendered the boardwalk provided for this purpose useless. Access via this point is being discouraged by a gravel stockpile.
Facilities provided:	Boardwalk
Planned uses catered for:	Walking
Concerns:	Dune degradation

Needs:	Dune rehabilitation							
Comment	Determine the frequency of use and need for this access point. Consider closure if sufficient alternative options are available or provide appropriate access infrastructure that would restrict further environmental damage. Rehabilitation of the dunes is required.							
	Priority Action Items							
Conflict	Environmental degradation/ damage	Safety and security	Identified need	Maintenance required	Further investigations required	Illegal activities		
	X				X

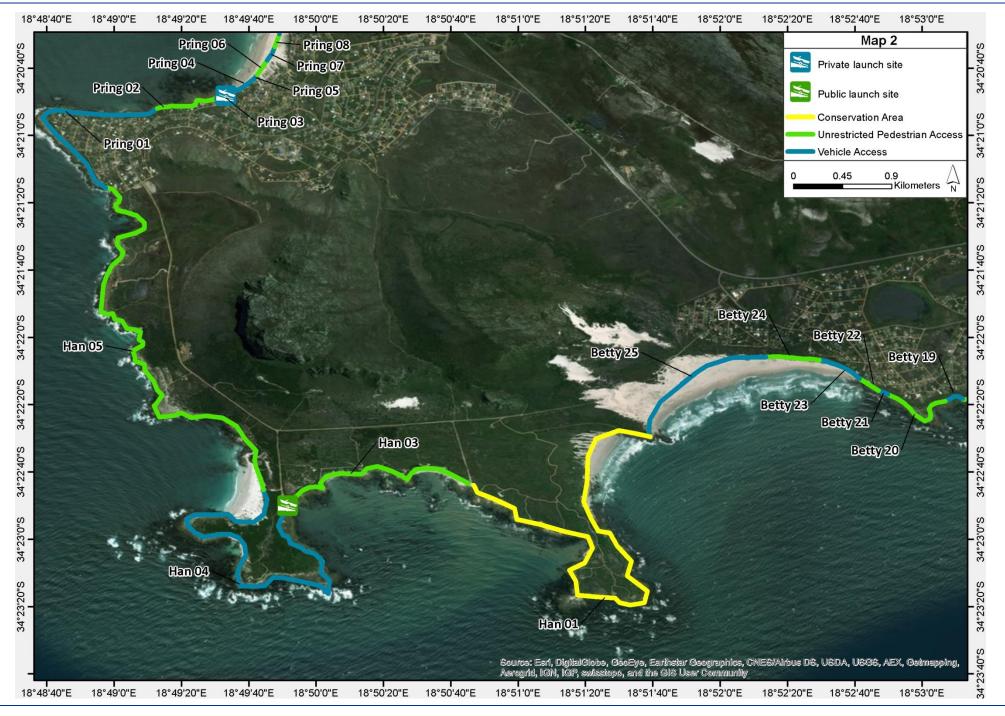
This map covers the remainder of Hangklip and the western portion of Betty's Bay. No conflict areas were identified and in general, public coastal access is adequate. The only place where access was in any way restricted was the conservation area (see Appendix 1). As with the previous sector, multiple informal pathways reflect a

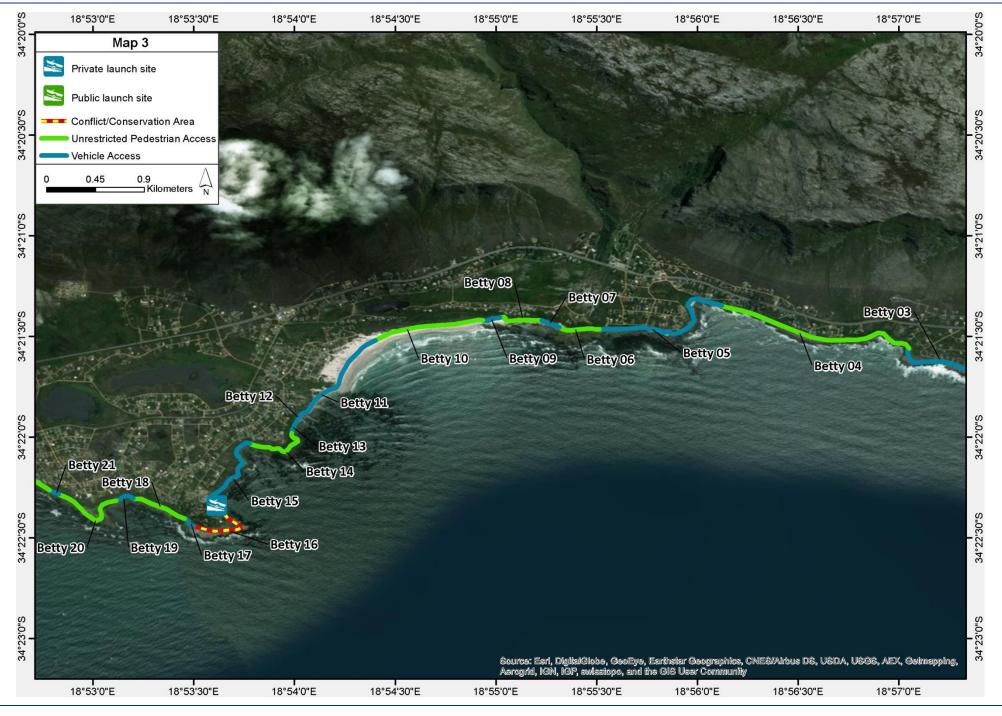
This map covers the bulk of Betty's Bay. Only one conflict area was identified (Betty 17). This area has been closed to fishermen to protect the penguin colony. However, the local stakeholders contend that co-existence is possible and that engagements with CapeNature should result in an amended management plan.

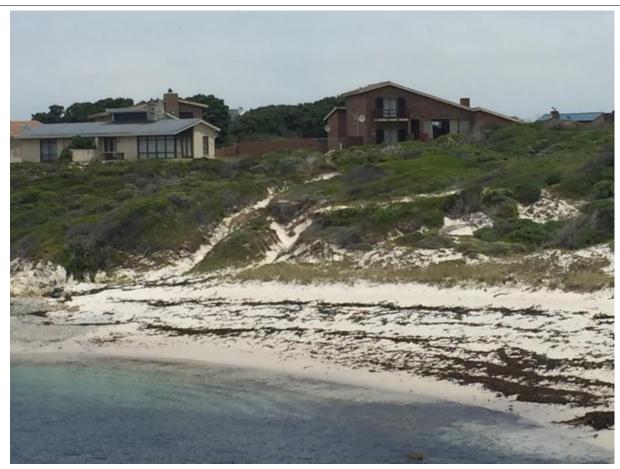
Town/area	Betty's Bay	
Site Ref:	Betty 05	
Description:	Multiple formal and informal pedestrian paths provide access to the rocky shore and small beach from the gravel roads and cul-de-sac's abutting the coast in this section. An informal pathway extends along the shoreline in this section.	
Facilities provided:	Signage, refuse bins, pedestrian paths, on-street and off-street parking (limited)	
Planned uses catered for:	es catered for: Walking, viewing, swimming, paddling, dog walking, surfing	
Concerns:	Evidence of dune erosion caused by pedestrian access pathways (dune above the beach)

Needs:	Access over dune that would prev	Access over dune that would prevent erosion (e.g. boardwalk). Dune rehabilitation is required.							
Comment	Nil	Nil							
	Priority Action Items								
Conflict	Environmental degradation/ damage	Safety and security	Identified need	Maintenance required	Further investigations required	Illegal activities			
	X			X

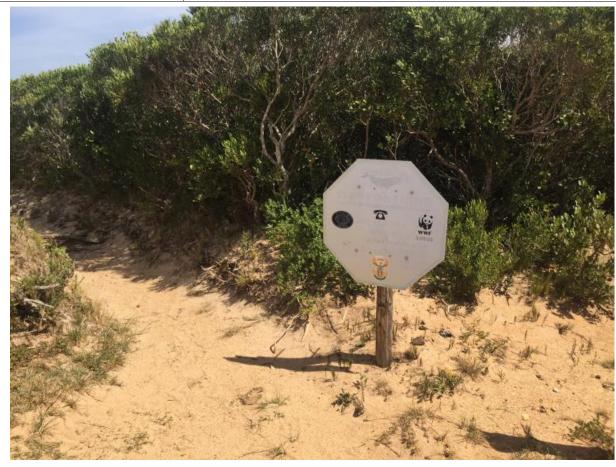
Town/area	Betty's Bay
Site Ref:	Betty 09
Description:	One formal pedestrian sand path physically detectible off Plateau Road (gravel road parallel to the coast). It is located between private property.
Facilities provided:	Signage (limited), sand pathway
Planned uses catered for:	Walking
Concerns:	No parking. Public comment indicated that the servitudes are poorly maintained. Only one pathway (indicating a possible servitude between houses) was noted during the site assessments.

Needs:	Servitudes that provide public acc	Servitudes that provide public access along this area to be identified and clearly demarcated. Parking possibilities to be investigated.							
Comment	Nil								
	Priority Action Items								
Conflict	Environmental degradation/ damage	Safety and security	Identified need	Maintenance required	Further investigations required	Illegal activities			
			X		X

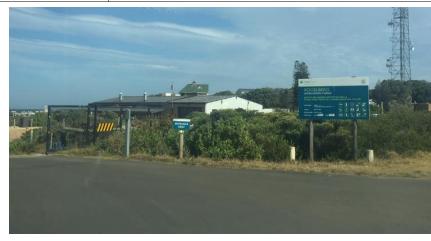
Town/area	Betty's Bay			
Site Ref:	Betty 16			
Description:	Cape Nature conservation area owing to colony of penguins. Unhindered public access no longer available.			
Facilities provided:	Public access facilities such as boardwalk, slipway etc. no longer in use due to access prevention by Cape Nature.			
Planned uses catered for:	Conservation, public access now blocked			
Concerns:	Conflict area. Public blocked from unhindered access and boat club members can no longer use the slipway.			
Needs:	Solution required to the conflicting uses of this area.

Comment Solution required to the conflicting uses of this area.

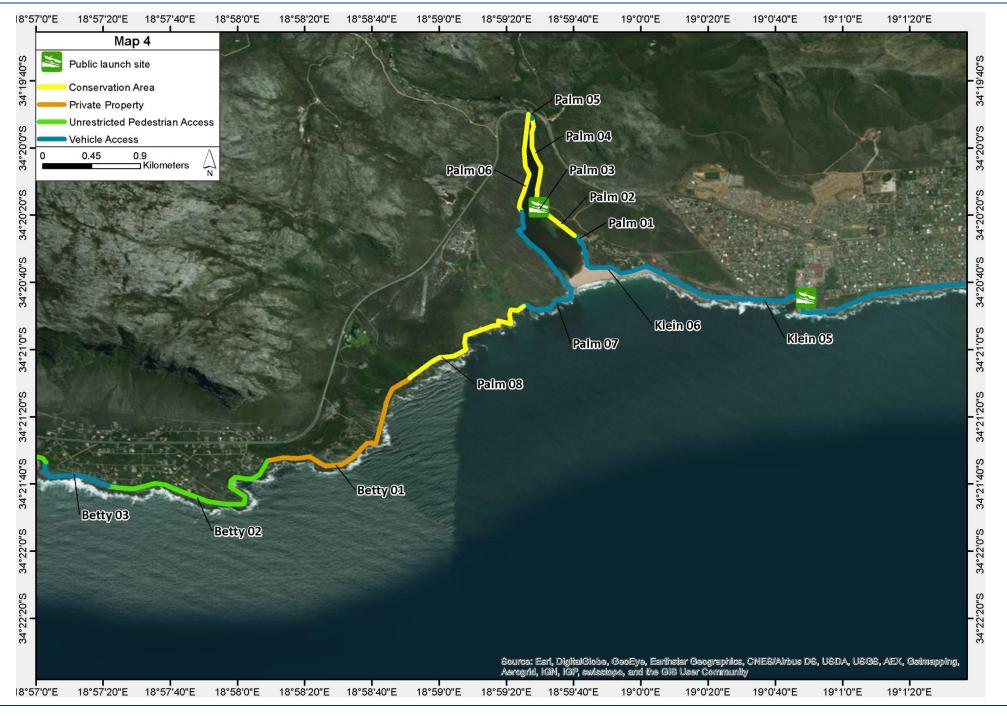
This map covers the area from the last three Betty's Bay sites, through Palmiet and the first five Kleinmond sites.

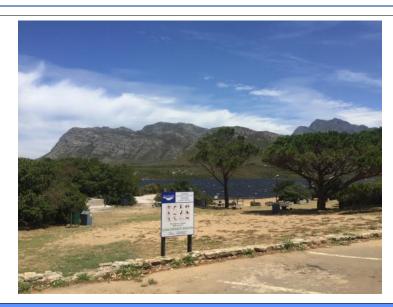
Town/area	Palmiet estuary					
Site Ref:	Palm 01					
Description:	Gravel access road off R44 leads to the main Palmiet estuary access point. Well frequented by day visitors.					
Facilities provided:	Signage, parking, kiosk, ablutions, lawns, benches, braai facilities, picnic tables, wheelchair reserved parking,					
Planned uses catered for:	Swimming, walking, viewing, dog walking, fishing, picnicking, wheelchair access					
Concerns:	Significant littering evident despite presence of refuse bins					
Needs:	Nil					
Comment	Contradiction between braai facilities provided and 'no fires' signage displayed – this must be investigated and rectified. Wheelchair parking provided but no other facilities to ease wheelchair access to the facilities / water edge. This was not identified as a need.

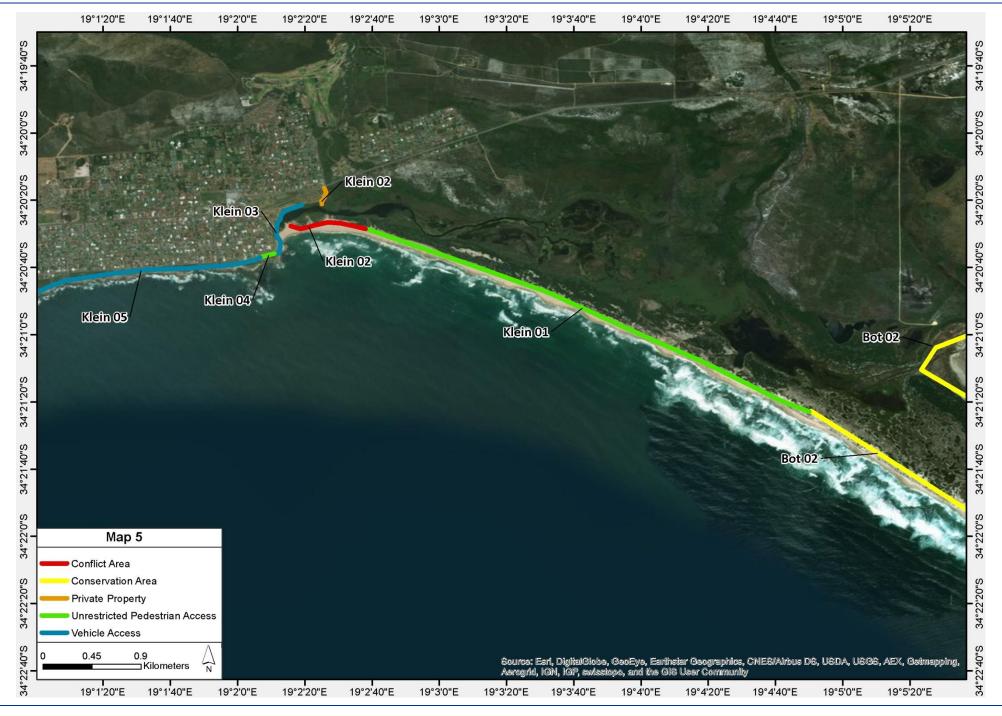
Map 5 covers the sector from eastern Kleinmond to the extreme western part of the Bot River sector.

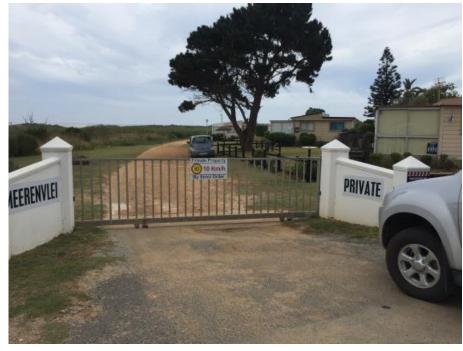
Town/area	Kleinmond
Site Ref:	Klein 02
Description:	Pedestrian access around private gated development off the R44 main road. Single sand access path leading to a boardwalk and wooden bridge spanning the estuary to provide access to the beach.
Facilities provided:	Access path, boardwalk, wooden bridge, walking
Planned uses catered for:	Vehicle transport across the Bot River
Concerns:	Conflict area. Vehicular access used to be possible before the development was gated. This resulted in access via a longer walk to the beach around the development. No parking provided for pedestrians using this access.

Needs:	Provision of parking							
Comment	Access is still possible via the boardwalk and also via the caravan park.							
	Priority Action Items							
Conflict	Environmental	Safety and security	Identified need	Maintenance	Further investigations	Illegal activities

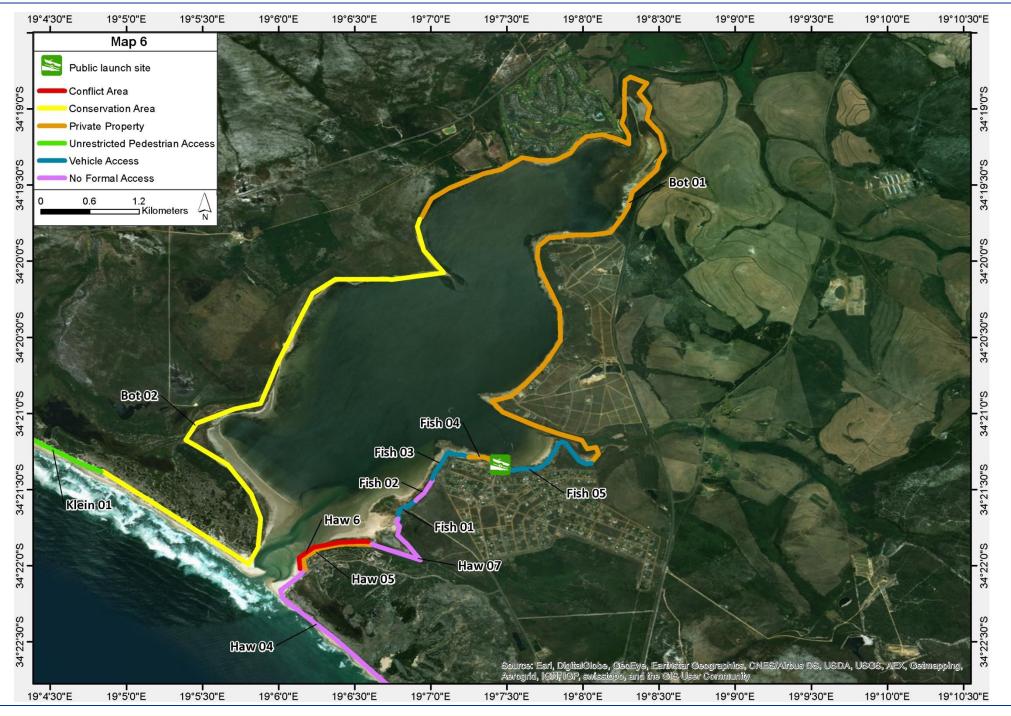
Map 6 covers the entire Bot River Estuary and the coastline on either side of the mouth. As can be seen from the map, apart from the areas in front of Fisherhaven, there is little public access to the Bot River. Access is restricted through conservation areas and privately owned land. The purple lines indicate that no formal access facilities or provisions have been supplied but access is not prevented in any way.

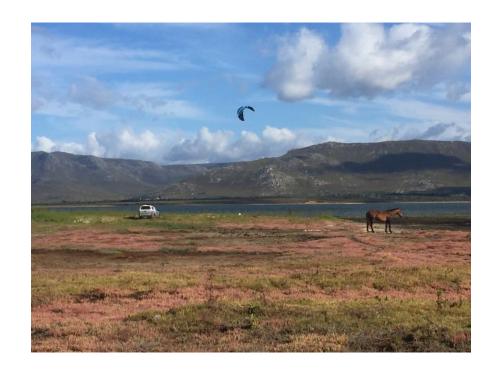
Town/area	Fisherhaven
Site Ref:	Fish 01
Description:	Single gravel access road to the estuary; frequently used vehicular tracks along ~200m of western mud bank; informal pedestrian pathways along shoreline and inland into adjacent fynbos corridor
Facilities provided:	Access road
Planned uses catered for:	Walking, viewing
Concerns:	Illegal vehicle access along the estuary shoreline. Illegal dumping of waste. Littering.
Needs:	Waste refuse bins. Bollards / other mechanism to prevent vehicular access along shoreline with appropriate parking where further vehicle access is denied.

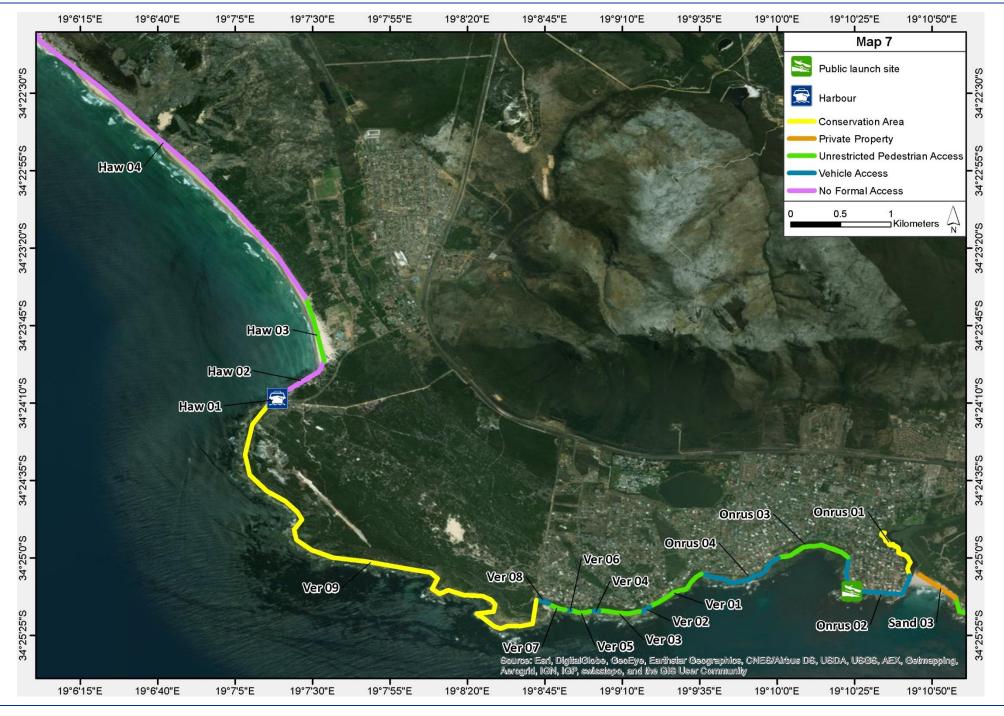
The sector from the eastern bank of the Bot River to the Onrus River did not identify any conflict zones. While a large sector (Ver 09) in Vermont is restricted for conservation purposes, the remainder of the sector has adequate coastal access.

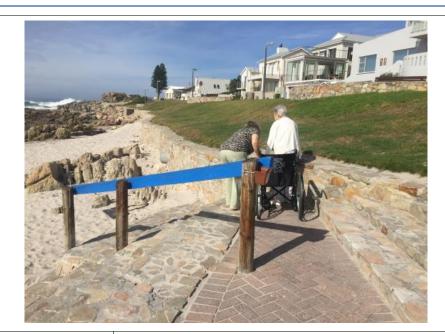
Town/area	Onrusrivier
Site Ref:	Onrus 02
Description:	Single one-way tarred road to main beach and along the coastline. Formalised pedestrian access to main beach and estuary mouth. Multiple informal footpaths to and along the remaining rocky shoreline. Network of formal gravel roads at 'Malherbe se Stoel' leading to a formal launch site.
Facilities provided:	Signage, refuse bins, benches, ablutions, parking, promenade, wheelchair friendly walkway/ramp, handrails, steps, life guards, sand slipway
Planned uses catered for:	Swimming, walking, viewing, dog walking, wheelchair access, boat launching
Concerns:	Wheelchair pathway provided from parking ends in several steps that must be negotiated to get access to the sand
Needs:	Wheelchair ramp to extend down onto the sand

At and north of Malherbe se Stoel, consider keeping only a single gravel road between the tar road and the shore and closing the other bifurcations off this road to prevent further encroachment on and loss of vegetation.

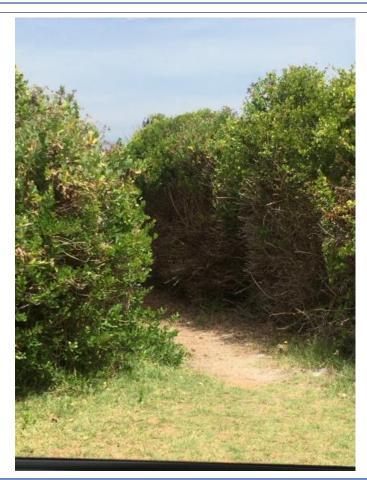
Town/area	Onrusrivier				
Site Ref:	Onrus 04				
Description:	Three formal paved and/or gravel access roads leading off the tarred road parallel to the coast. All end in a turning circle that serves as parking and are intersected by the continuation of the formalised coastal path that comprises of a combination between concrete surface and boardwalk sections. Multiple formal pedestrian pathways to the water from the coastal path including access to two tidal pools (one wheelchair friendly). Multiple informal footpaths through coastal vegetation from the tarred road.				
Facilities provided:	Signage, refuse bins, benches, ablutions, parking, coastal pedestrian path, wheelchair friendly walkway/ramp, handrails, exercise park, access for food truck vendors, dog waste specific refuse bins, tidal pools, vehicle movement longshore limited by locked gates.				
Planned uses catered for:	Swimming, walking, viewing, dog walking, wheelchair access

Concerns:	Nil				
Needs:	Nil				
Comment	The informal footpaths from the tar road are likely frequented by the residents immediately opposite those pathways. These do not present significant encroachment on coastal vegetation at this point, but should be monitored to prevent proliferation of pathways and loss of vegetation. Legality of these pathways must be determined.

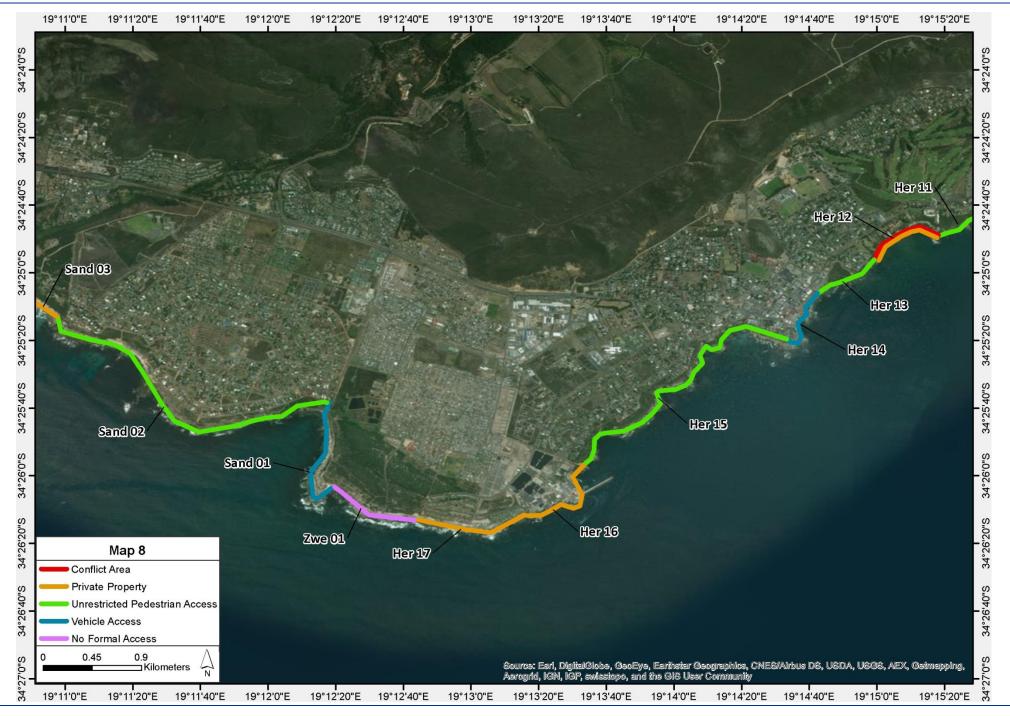
The coastal areas of Sandbaai, Zwelihle and the western part of Hermanus are depicted in map 8.

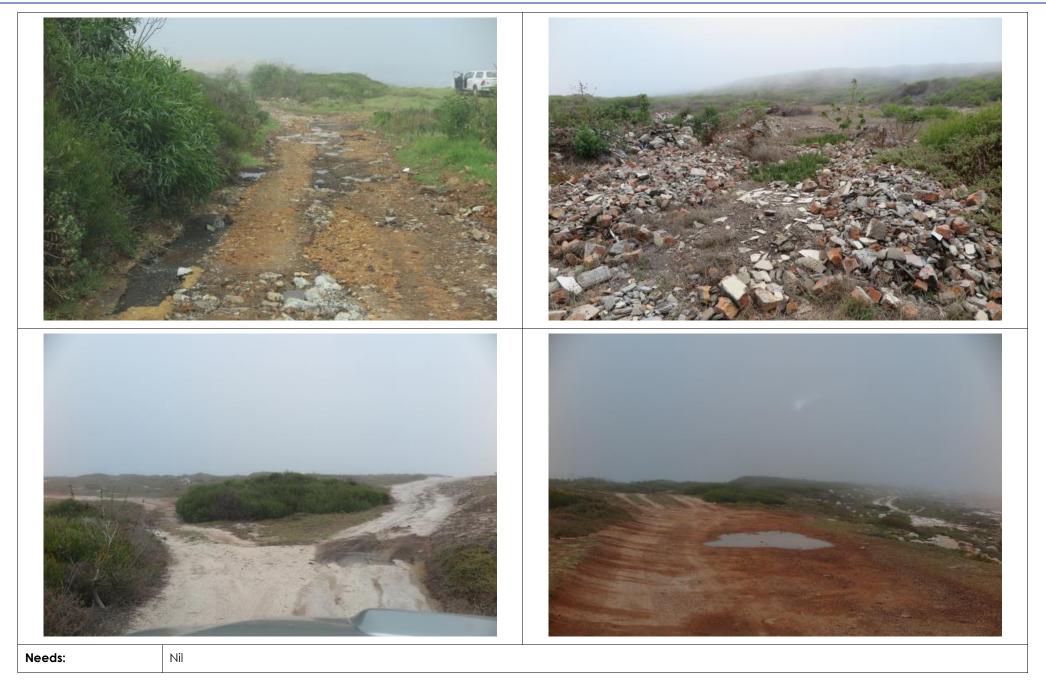
Town/area	Sandbaai
Site Ref:	Sand 01
Description:	A formalised, graded gravel road has been constructed from the eastern edge of Sandbaai towards the south. The road is not well maintained and is not accessible to a family vehicle. As it nears the southern extent, further tracks arise from it to form a network of tracks in and through the dunes. It is evident that this area is used for illegal dumping amongst other things. Although there is a proliferation of tracks, there is no evidence of large-scale significant dune degradation although the legality of the tracks is uncertain.
Facilities provided:	Gravel road to southern tip
Planned uses catered for:	
Concerns:	Proliferation of informal tracks through dunes

Comment	The Municipality should addressed.	The Municipality should consider formalising the tracks and restrict the number and extent of additional tracks. The illegal activities need to be addressed.						
	Priority Action Items							
Conflict	Environmental degradation/ damage	Safety and security	Identified need	Maintenance required	Further investigations required	Illegal activities		
				X	X	X

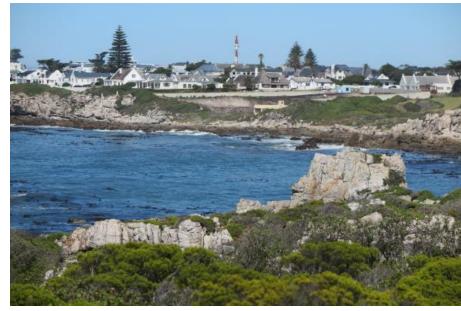
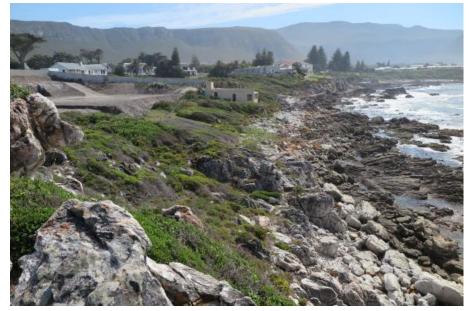
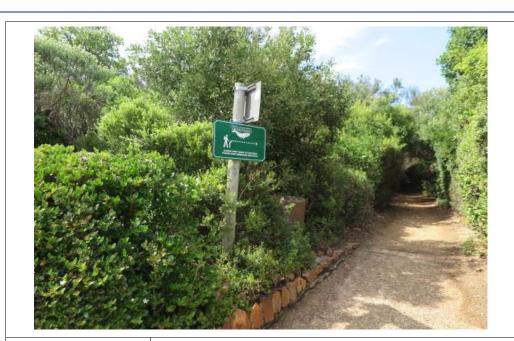
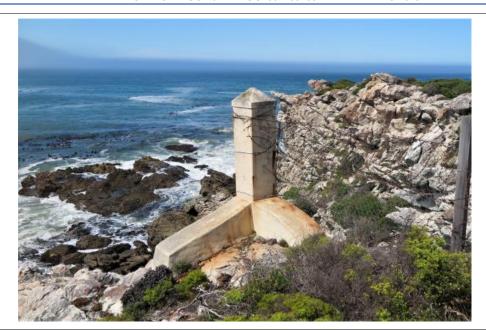
Town/area	Hermanus
Site Ref:	Her 12
Description:	This is a short stretch in which private properties run down to the high water mark thereby cutting off the cliff path to the east and west. This is a conflict area and has attracted much publicity recently. Coastal access is denied along this stretch.
Facilities provided:	Nil- access is denied
Planned uses catered for:	Nil
Concerns:	This is a conflict area and the right of access for the public need to be resolved.

Needs:	
Comment	The concern that these properties sever the Cliff path has attracted much publicity. The investigations into the situation by the Municipality are ongoing.

A conflict area was identified by stakeholders at Her 12- the Cliff Path. A pedestrian pathway of various types of construction runs along the entire Hermanus beachfront area except for a break in the Her 12 area where private property runs to the High Water Mark. Stakeholders have urged that these private landowners permit access to complete the walkway. This has been referred to the local authority for attention.

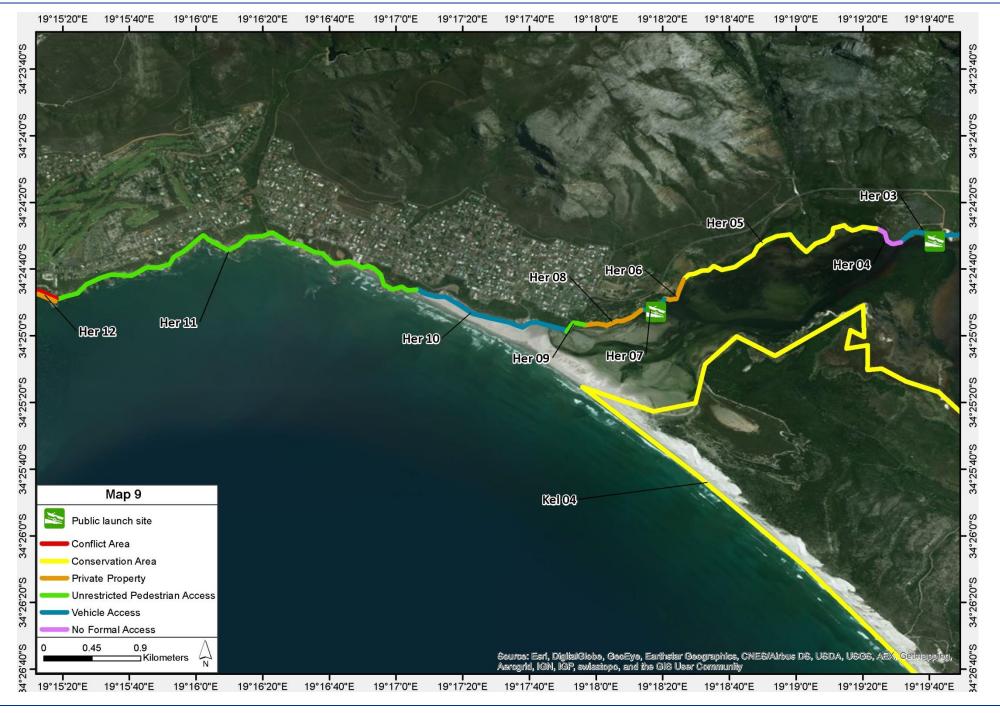
No conflict areas are identified in Maps 9 and 10. It covers the remainder of Hermanus, the Klein Estuary and the western side of Die Plaat conservation area. Public access to the Klein Estuary is restricted to the beach to the west of the mouth, two formal launch sites and through private resorts. This was not raised as a concern in the workshops. Area Kel 04 (Die Plaat) stretches onto Map 11 and 12 in order to maintain a consistent scale to the maps.

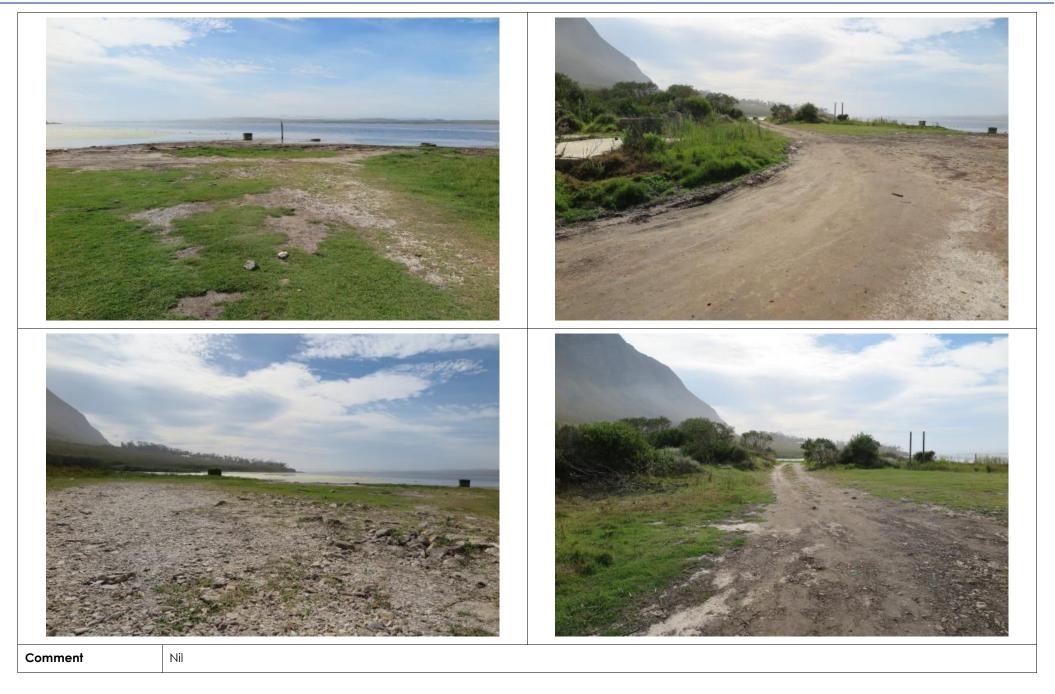
Town/area	Hermanus
Site Ref:	Her 02 and 03
Description:	With the exception of Her 03 (Klein launch site) this stretch of water's edge does not have any formal access provision. It comprises unstable muddy banks and vehicular access is difficult other than via the launch site.
Facilities provided:	The launch site has a parking and turning area, picnic facilities
Planned uses catered for:	Boat launching, picnic slab- no other facilities than refuse bins
Concerns:	Nil
Needs:	The area shows signs of frequent and intensive use. The Municipality should consider installing ablutions and water pipes. This need was expressed by users of this launch site.

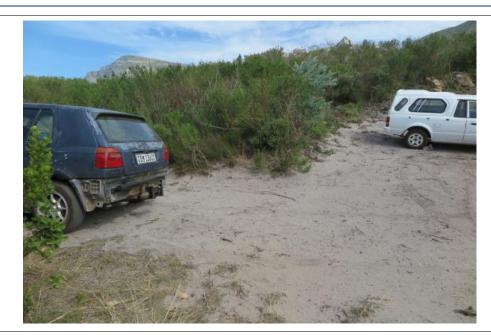
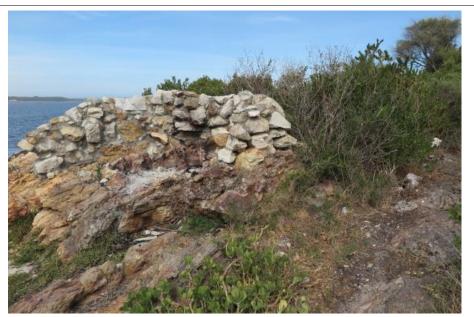
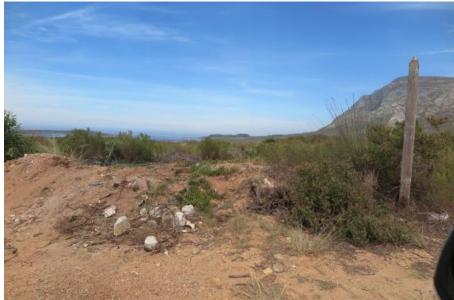
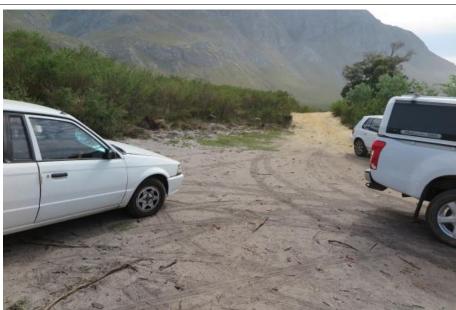
Town/area	Hermanus
Site Ref:	Her 06, 07 and 08
Description:	This stretch of the lagoon is private property on muddy banks. Access is restricted except at the Prawn Flats Launch Site (Her 07)
Facilities provided:	The launch site has a parking and turning area. picnic facilities
Planned uses catered for:	Boat launching, picnic slab- no other facilities than refuse bins
Concerns:	Nil
Needs:	The area shows signs of frequent and intensive use. The Municipality should consider installing ablutions and water pipes. This need was expressed by users of this launch site.

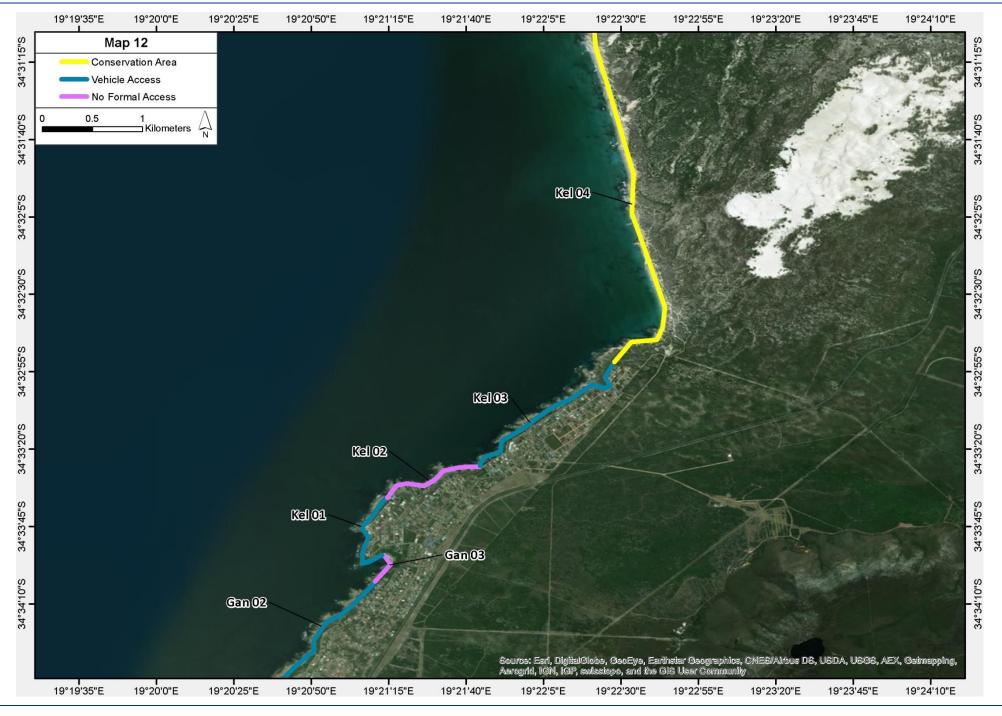
Map 12 sohws the end of Kel 04 and covers Die Kelders and the eastern portion of Gansbaai.

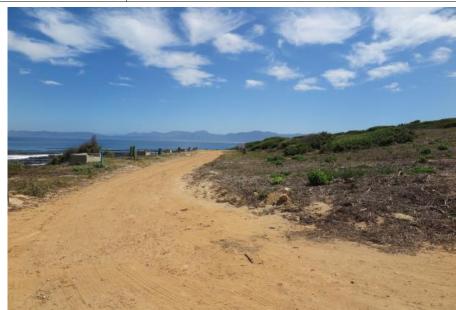
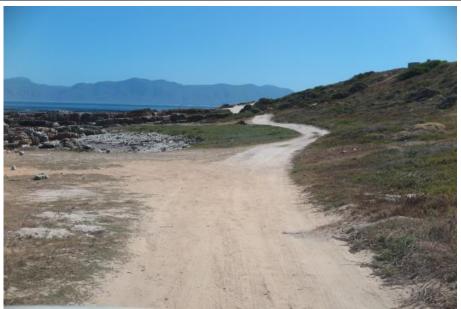
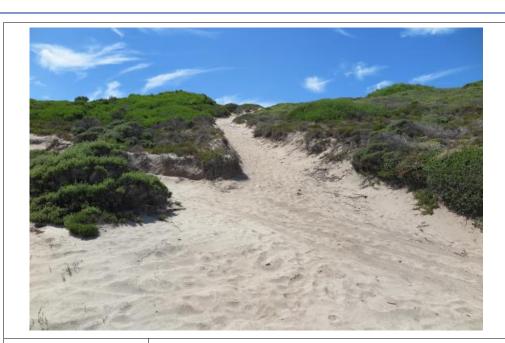
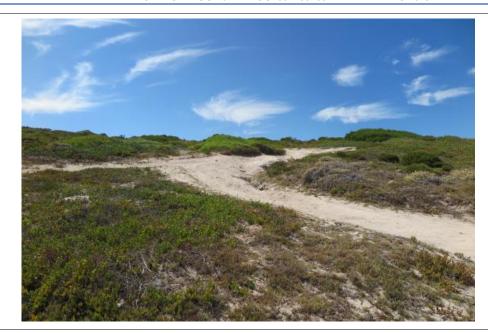
Town/area	Blompark
Site Ref:	Blom 01
Description:	A well maintained gravel road runs through Blompark to the coast. At its terminus is a recreation area. The track runs north-east towards Gansbaai Harbour over the rocky coast with numerous informal paths to the sea but no further facilities other than a few refuse bins. This track appears not to be maintained and there is evidence of lateral migration and expansion.
Facilities provided:	At the terminus are braai facilities, ablutions, shelters, drinking water, signage, parking area and refuse bins.
Planned uses catered for:	Picnic/ braai, fishing, viewing
Concerns:	The track to the north-east shows evidence of lateral migration to avoid potholes etc as they develop. This results in an overall increase in the footprint of the "road" to the detriment of the dune vegetation. This should be formalised to prevent such expansion.

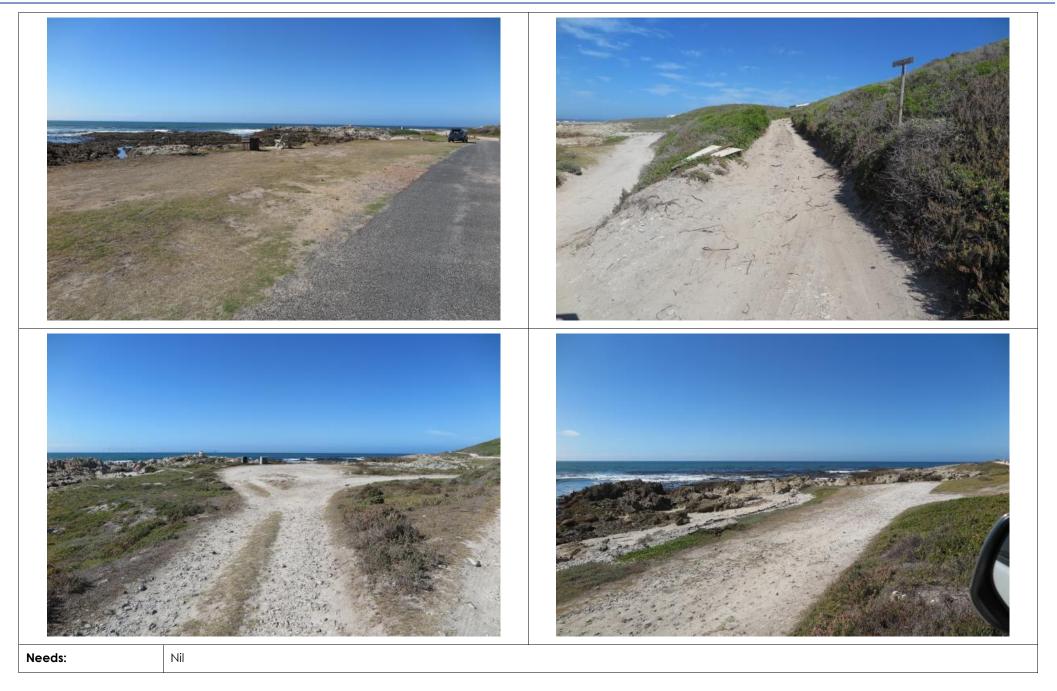
Town/area	Kleinbaai
Site Ref:	KleinB 01
Description:	Rocky coastline in front of residences. A gravel track runs parallel to the coastline with numerous informal paths leading to the sea.
Facilities provided:	Gravel track
Planned uses catered for:	Viewing, fishing, conservation
Concerns:	The legality of this track is uncertain

Comment	There is little evidence	There is little evidence of any significant damage to dune vegetation					
Priority Action Items							
Conflict	Environmental degradation/ damage	Safety and security	Identified need	Maintenance required	Further investigations required	Illegal activities	
					X	?

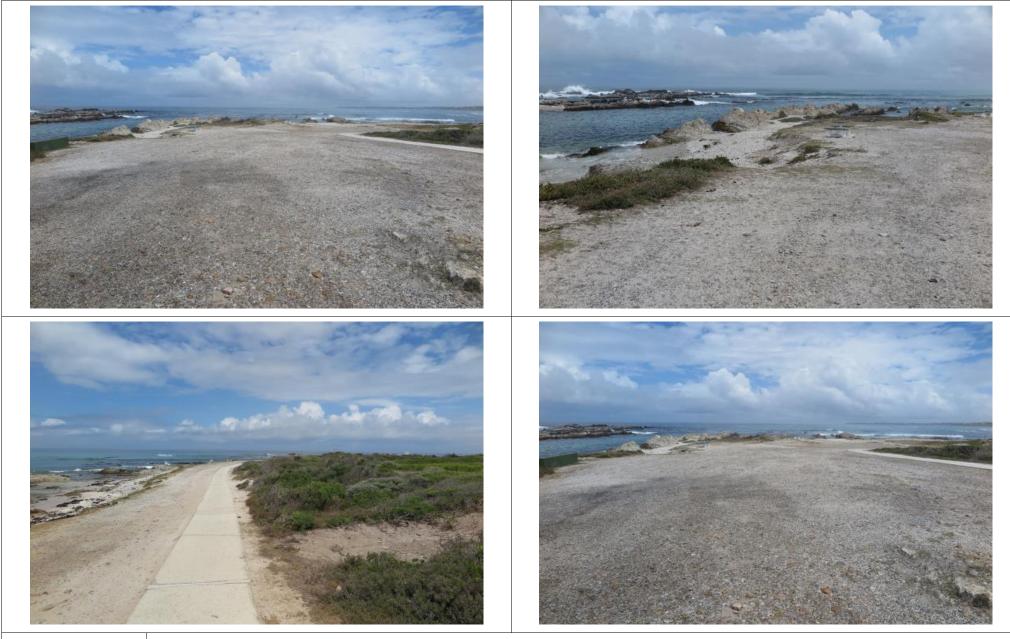
Town/area	Franskraal
Site Ref:	Frans 03 and 04
Description:	The main front tarred road runs between the last row of houses and the rocky shore the entire length of Franskraal towards Kleinbaai. There are numerous paved pull-off pedestrian pathways with benches and tables for viewing. There are also numerous informal gravel roads straddling the pathways to turning circles on the rocky shore. While these appear to be maintained, their presence is questioned. There is evidence of lateral expansion and migrate of the informal roads to the detriment of the dune vegetation.
Facilities provided:	Paved walkway- disabled parking and access to pull-offs, signage, refuse bins, receptacles for waste fishing line
Planned uses catered for:	Fishing, viewing, bird watching, conservation, walking dogs on leash

The gravel vehicle tracks that straddle the paved walkways show evidence of lateral expansion and migration. It is questioned whether these tracks are legal and necessary

Needs:	Nil	Nil						
Comment	be deemed necessar	he Municipality should investigate whether the vehicle tracks are in fact necessary given the close proximity of the main tarred road. Should they be deemed necessary, they should be formalised and the lateral extent limited with post and rail. If they are deemed unnecessary they should be closed with barriers to prevent vehicle entrance.						
	Priority Action Items							
Conflict	Environmental degradation/ damage	degradation/ Safety and security Identified need Maintenance Further investigations Illegal activities						
				X	X	?

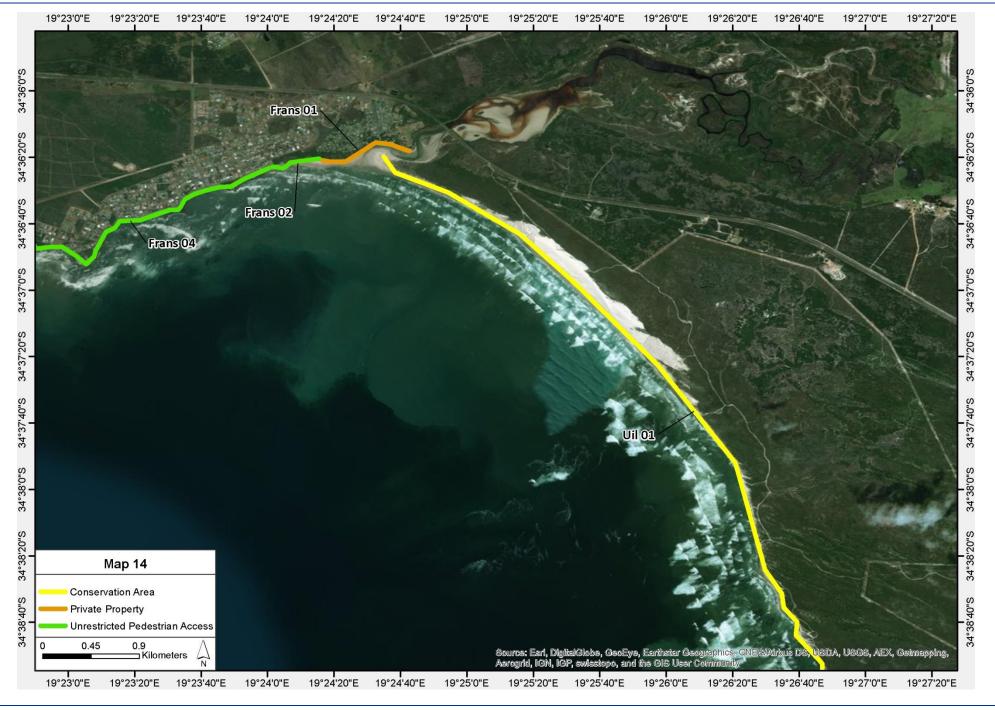
The coastline in Franskraal is well provided with access. From Frans 05 to 01 a concrete pathway is provided through the dunes between the coastal road and the sea. This is well maintained and supplied with parking areas, refuse bins etc. However, additional vehicle tracks leading from these parking areas onto the rocks were obvious. Although the damage was localised as a consequence of

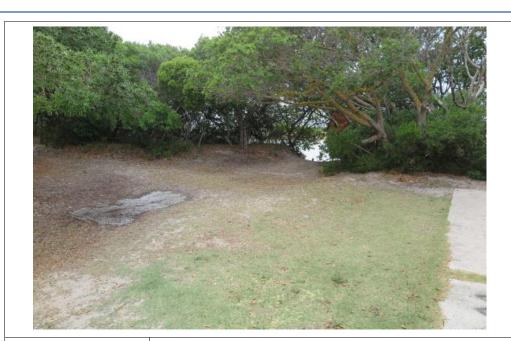
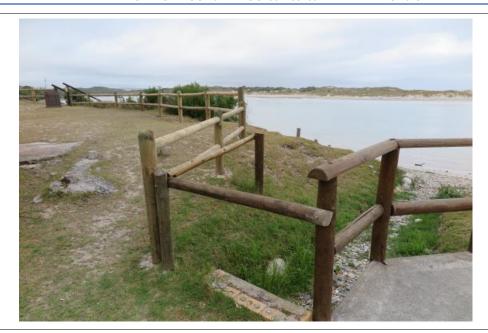
Town/area	Franskraal
Site Ref:	Frans 01
Description:	Private property- owned by the municipality skirts the western bank of the Uilenkraalsmond. Access is via a boom through a formal footpath or sand paths/ wooden stairways in the caravan/ camp site.
Facilities provided:	Caravan/ camping ground, ablutions, kiosk, restaurant, wooden stairways, parking and turning facilities, children's playground
Planned uses catered for:	Swimming, fishing, caravan/ camping, walking dogs on leash, bird watching, picnic
Concerns:	Numerous informal access routes to beach via campground

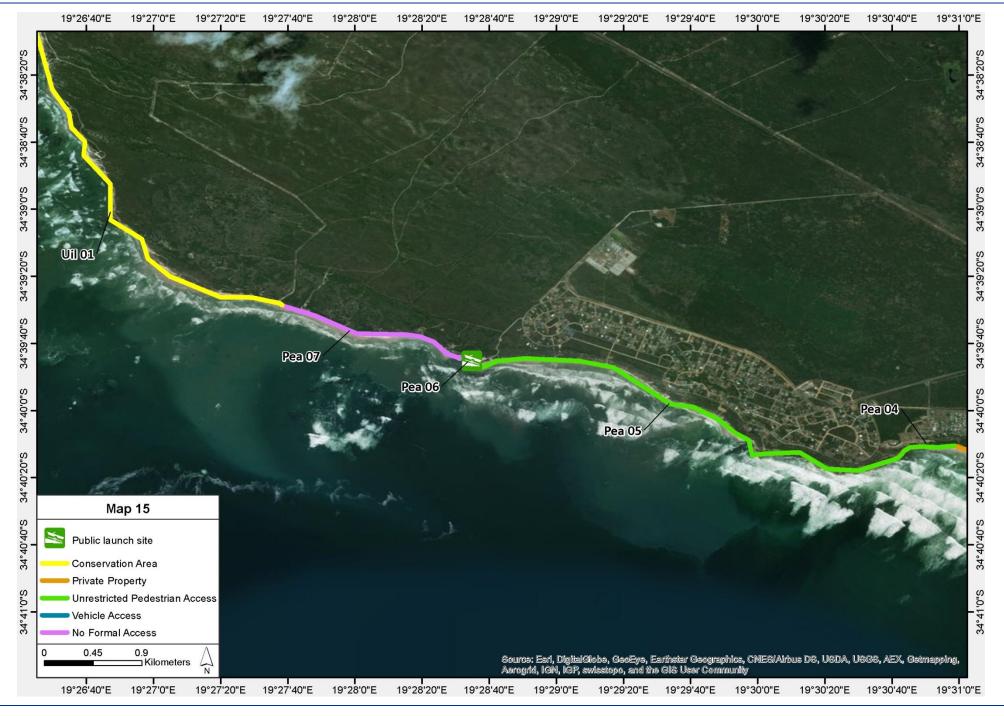
Map 14 already showed the location of the conservation area Uil 01. The remainder of Pearly Beach is well supplied with access points including a launch site. These formal access points notwithstanding numerous additional informal access points have developed through the dunes. Furthermore, as was noted in the previous sector, informal vehicular access tracks radiate from the formal parking areas resulting in damage to the dunes. These should be closed and rehabilitated.

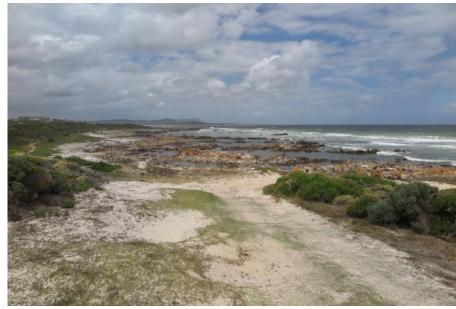
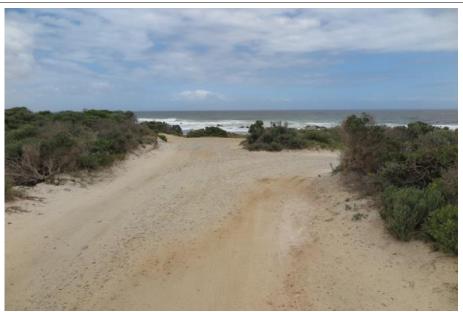
Town/area	Pearly Beach					
Site Ref:	Pea 05					
Description:	This zone stretches from the main beach to the launch site in the West. It is generally a rocky coastline with sand pockets. The tarred municipal access road runs parallel to the coastline and numerous formal and informal roads and paths lead from this tarred road to the sea.					
Facilities provided:	Some of the side roads have small parking areas, others not. Bins and some signage.					
Planned uses catered for:	Fishing, walking, sire seeing, walking dogs on leash, conservation					
Concerns:	There is evidence that the informal roads and paths are causing damage to the dunes and its vegetation and they may not be legal; proliferation would be a problem. There is clearly a need for a more formal access points. The municipality should conduct a needs analysis and attempt to plan to limit the number and extent of these paths.

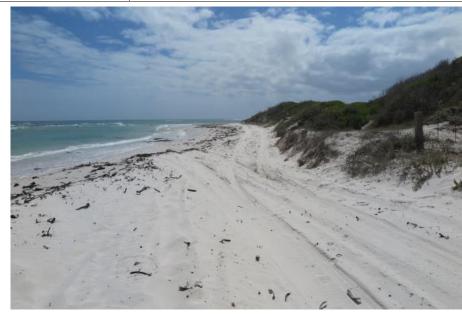
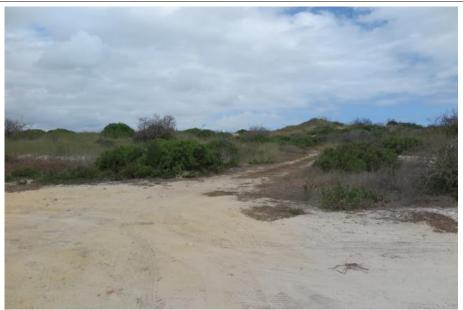
Town/area	Pearly Beach
Site Ref:	Pea 06
Description:	Designated launch site
Facilities provided:	Gravel road from Pearly Beach West. A derelict boom and gate-house are situated at its western terminus. They appear to no longer be in use. There is no turning circle or parking area at the terminus. Any turning must take place on the beach or encroach into the dune vegetation. It is uncertain how the ORV permits are checked for vehicles using this road.
Planned uses catered for:	Boat launch. fishing
Concerns:	The road is not well maintained and there is evidence of lateral migration into the dune vegetation resulting in an increasing footprint of damage. The lack of a turning circle and parking area at the terminus means that the dune vegetation is frequently damaged by vehicles and vehicles have to go onto the beach itself in contravention with legislation at times. Stakeholders claimed that this launch site is used to gain illegal access the private property and conservation land to the west.

Needs:	There is clearly a need for this launch site but it needs to be better managed to prevent illegal activities and damage to the dunes.								
Comment	As above								
	Priority Action Items								
Conflict	Environmental degradation/ damage	degradation/ Safety and security Identified need Maintenance Further investigations Illegal activities							
	Х			Х	X	X

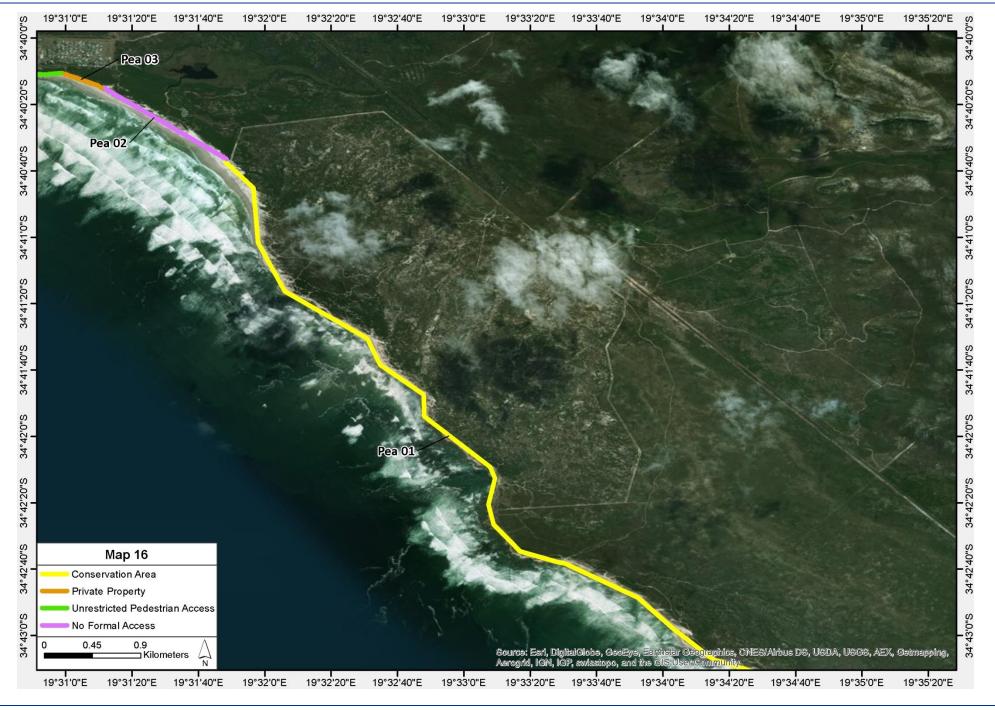
Map 16 depicts the small residential development at Pearly Beach through which coastal access is restricted but not denied. The long conservation area (Per 01) stretches over maps 16 and 17).
