Western Cape Provincial Coastal Access Assessment and Pilot Study

MAIN REPORT

August 2018

Draft for public comment

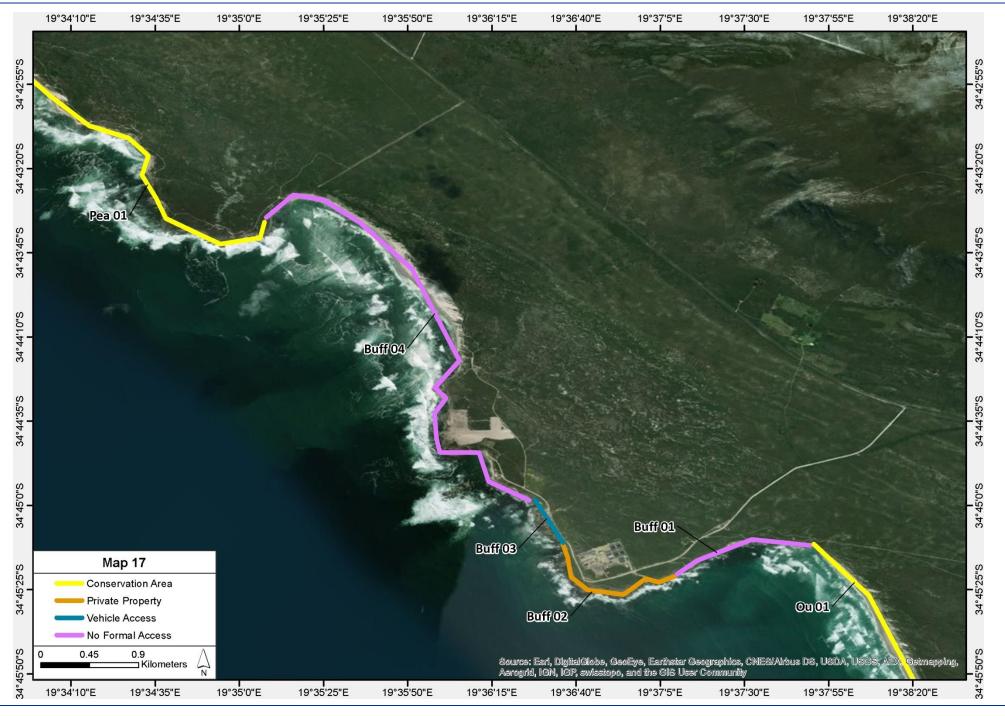
Map 17 shows the whole of Buffelsjag settlement. While no formal access provision was evident there is a gravel road along the coast which provides access to a launch site. No environmental damage was observed at the time of the site visit. Access is only denied at Buff 02 in front of the abalone farm.

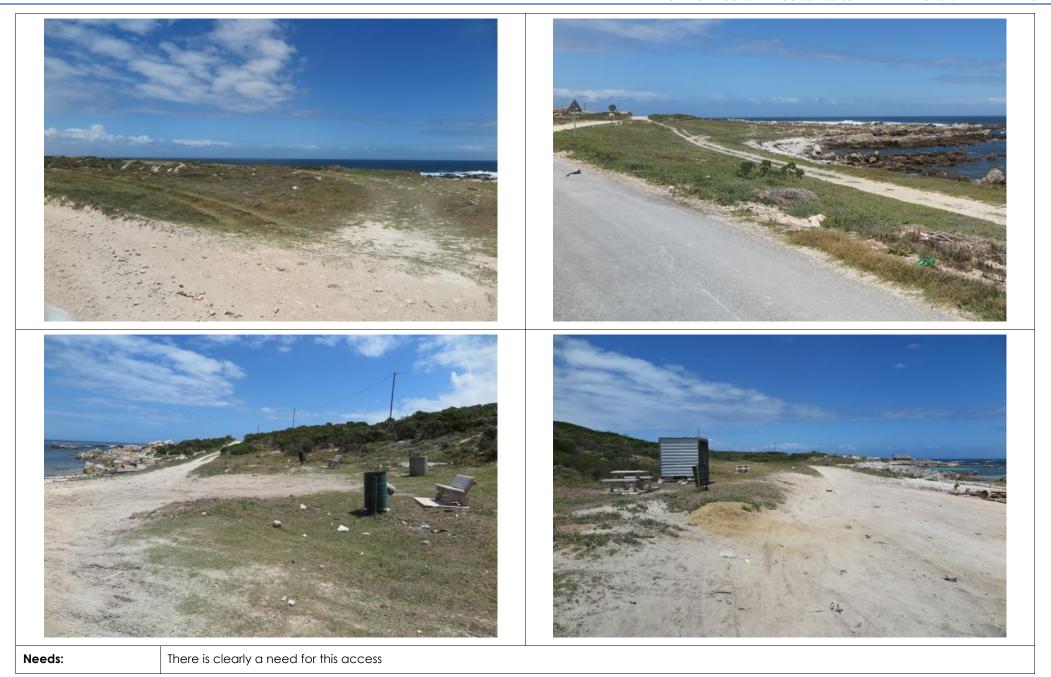
Town/area	Buffelsjag
Site Ref:	Buff 04
Description:	The main gravel access road running through Buffelsjag continues in a generally north-westerly direction to the beach and splits into numerous side roads with numerous informal paths between the roads and the sea. Access is unrestricted and a boat launching site is designated on the beach
Facilities provided:	Benches and refuse bins are provided but not maintained. Launch site, signage.
Planned uses catered for:	Fishing , boat launching
Concerns:	The proliferation of roads and paths into the dune vegetation is a source of concern. The Municipality should investigate whether these can be limited and formalised to limit the damage to the vegetation.

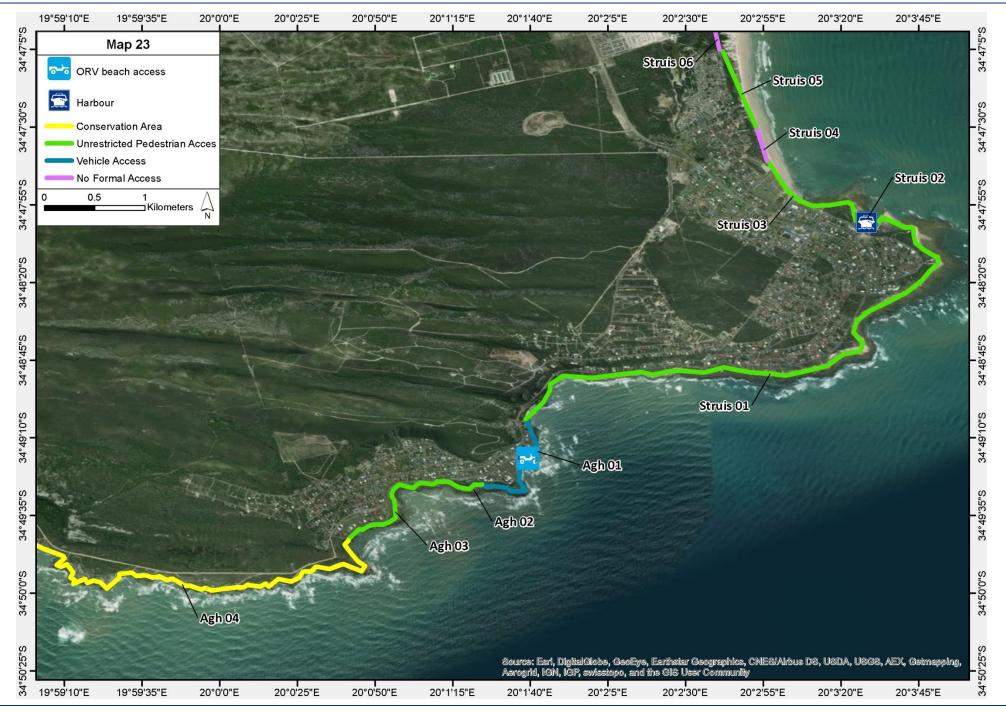
Map 23 covers Cape Agulhas and part of Struisbaai. The map shows that there is little restriction to coastal access in this sector. Indeed, numerous pull-offs and parking/picnic areas have been provided in Cape Agulhas and Struisbaai. However informal vehicle tracks have developed between them along the coastline. The necessity and

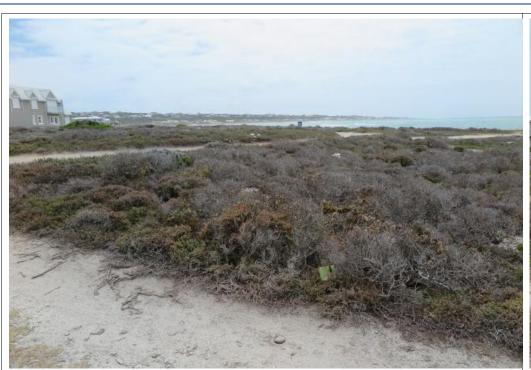
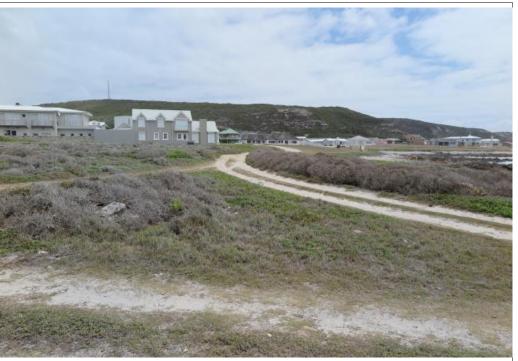
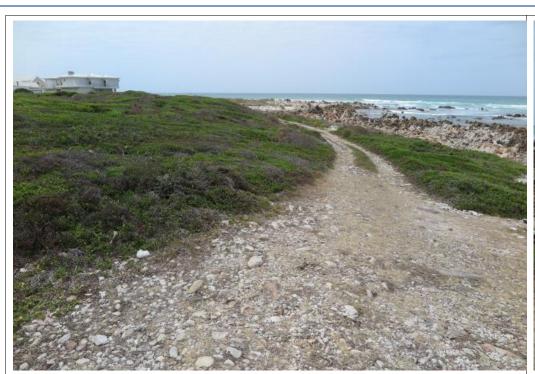
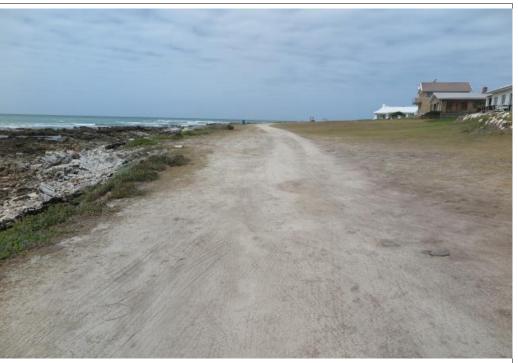
Town/area	L'Agulhas
Site Ref:	Agh 01
Description:	A stretch of rocky shore with a gravel road running along the rock platform parallel to the tarred road to the historic chapel giving rise to additional informal pedestrian access points
Facilities provided:	Bins, benches
Planned uses catered for:	Sight-seeing, dog walking on leash
Concerns:	The need for this parallel road is questioned as the main tarred road is so close. The gravel road shows signs of lateral expansion to the detriment of the dune vegetation. Such roads may also be illegal. They need to be closed

Needs:	There is a need to provide parking along the main road so that traffic is not disrupted in peak season if the gravel road is closed.
Comment	Nil

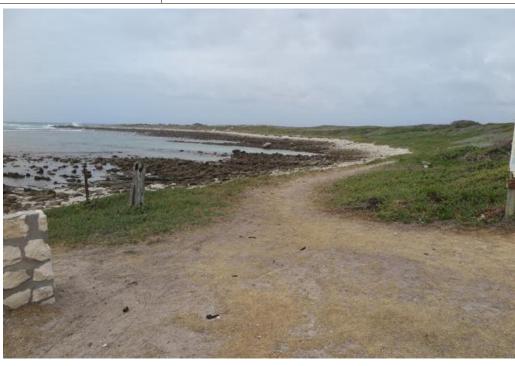
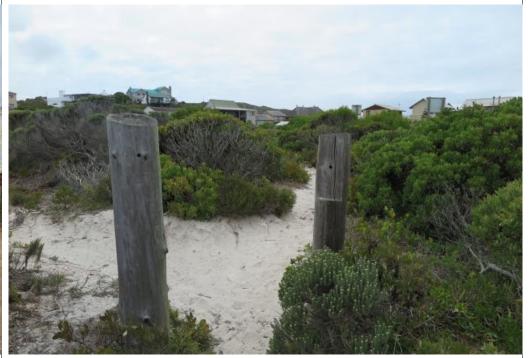
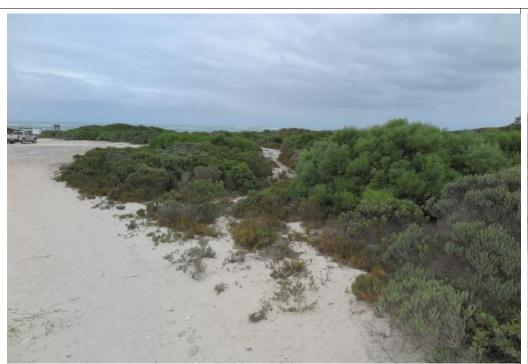
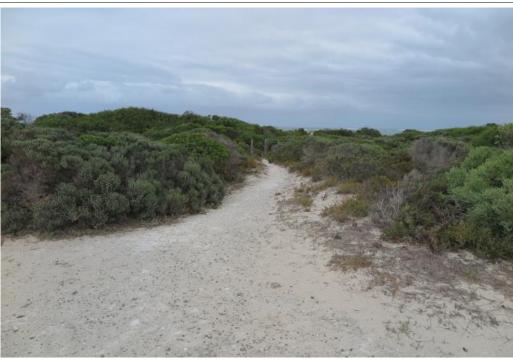
Town/area	L'Agulhas
Site Ref:	Agh 02
Description:	Unrestricted pedestrian access via formal paths from the main tarred road. A gravel road parallels the main tarred road along the top of the rocky platform.
Facilities provided:	Bins, benches
Planned uses catered for:	Sight-seeing, dog walking on leash
Concerns:	The need for this parallel road is question as the main tarred road is so close. The gravel road shows signs of lateral expansion to the detriment of the dune vegetation. Such roads may also be illegal. They need to be closed

Needs:	There is a need to provide parking along the main road so that traffic is not disrupted in peak season if the gravel road is closed.
Comment	Nil

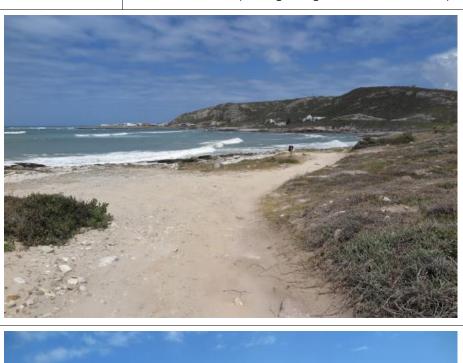
Town/area	Struisbaai
Site Ref:	Struis 01
Description:	A stretch of rocky shore from the Harbour to L'Agulhas. Municipal roads have been constructed between the houses and the seafront and numerous formal and informal access points arise from that road. In some areas to the west of the stretch parallel informal roads have developed alongside the footpath on the tops of the rocky platform. These provide vehicle access to the picnic and viewing sites but have damaged the vegetation.
Facilities provided:	Frequent pull-off sites from the tarred road. Benches and refuse bins. A continuous footpath along the coast with frequent picnic/ sight-seeing nodes.
Planned uses catered for:	Picnic, sight-seeing, dog walking on leash
Concerns:	The informal roads which run parallel to the footpaths allow illegal access of vehicles into the coastal zone. There is also lateral migration and expansion of these roads leading to further degradation of the dune vegetation. As the area is a rocky platform, erosion is not likely to be a problem but destruction of the dune vegetation could result in windblown sand migration.

There is a need for parking along the road and this may be used as an excuse for the informal roads.

Comment	The informal roads runni	he informal roads running parallel to the footpath should be closed.					
Priority Action Items							
Conflict	Environmental degradation/ damage	Safety and security	Identified need	Maintenance required	Further investigations required	Illegal activities	
	X			Х	X	X

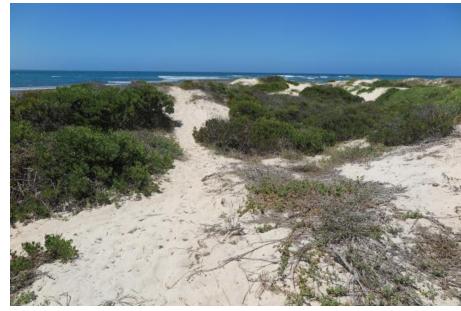
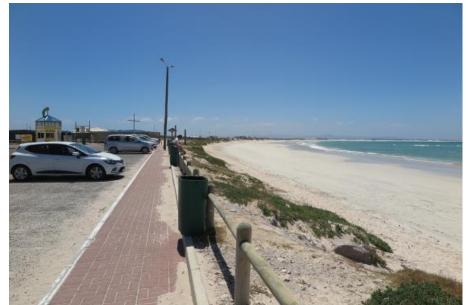
Town/area	Struisbaai
Site Ref:	Struis 05
Description:	A strip of coastline in front of Argonaut. There are a small number of formal access points from the perimeter roads through the vegetated dunes to the beach and numerous informal tracks through the dunes from individual properties.
Facilities provided:	A small number of formalised paths to the beach between the houses, refuse bins, signage.
Planned uses catered for:	Walking, dog walking
Concerns:	The numerous informal tracks from individual houses should be closed as they are not legal and cause damage to the dunes.

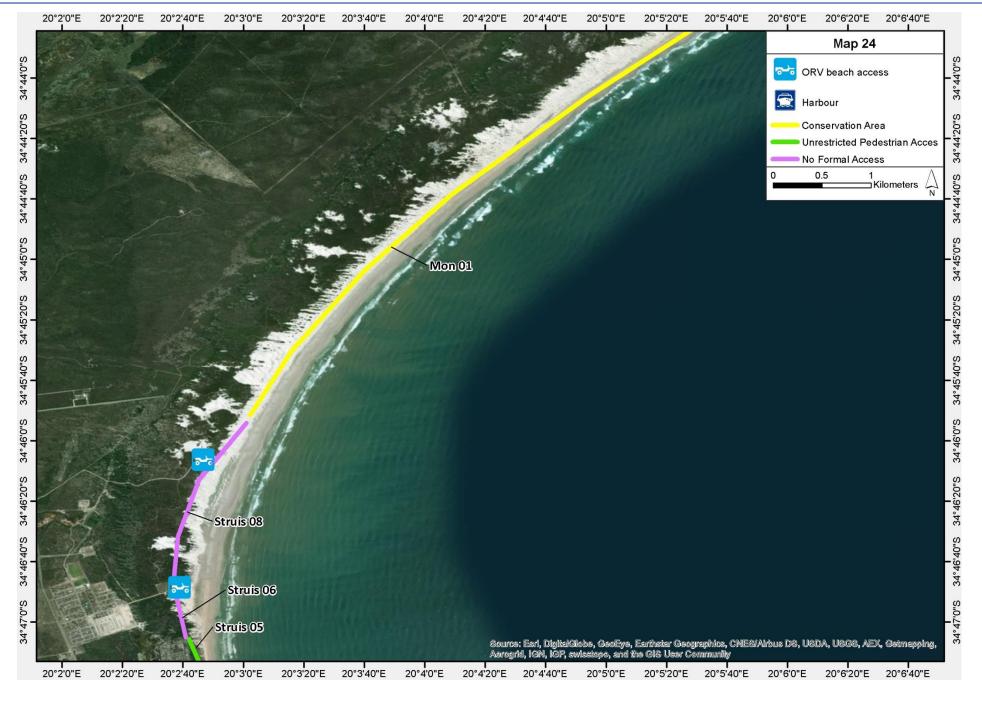
Map 24 covers the remainder of Struisbaai and the western portion of Die Mond which continues on map 25.

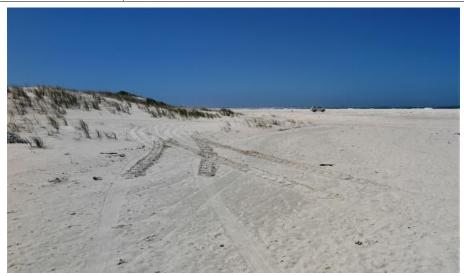
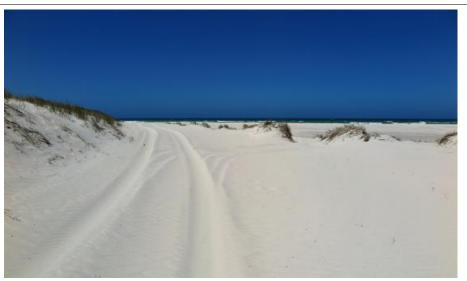
Town/area	Struisbaai					
Site Ref:	Struis 07					
Description:	Municipal road through Molshoop through the dunes to a small parking area with derelict ablution buildings and then over the dunes to the beach					
Facilities provided:	Municipal road to the dunes					
Planned uses catered for:	Fishing					
Concerns:	The access to the beach is unregulated and the number of vehicle tracks suggests frequent use. There is no lateral encroachment into the dune vegetation but illegal beach access by vehicles is likely.

Needs:	The access is well maintained and clearly needed but a mechanism of enforcing the ORV regulations must be implemented.
Comment	Nil

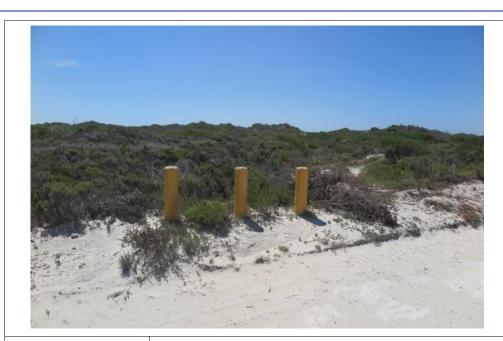
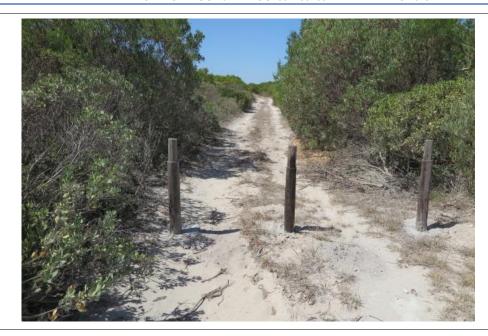
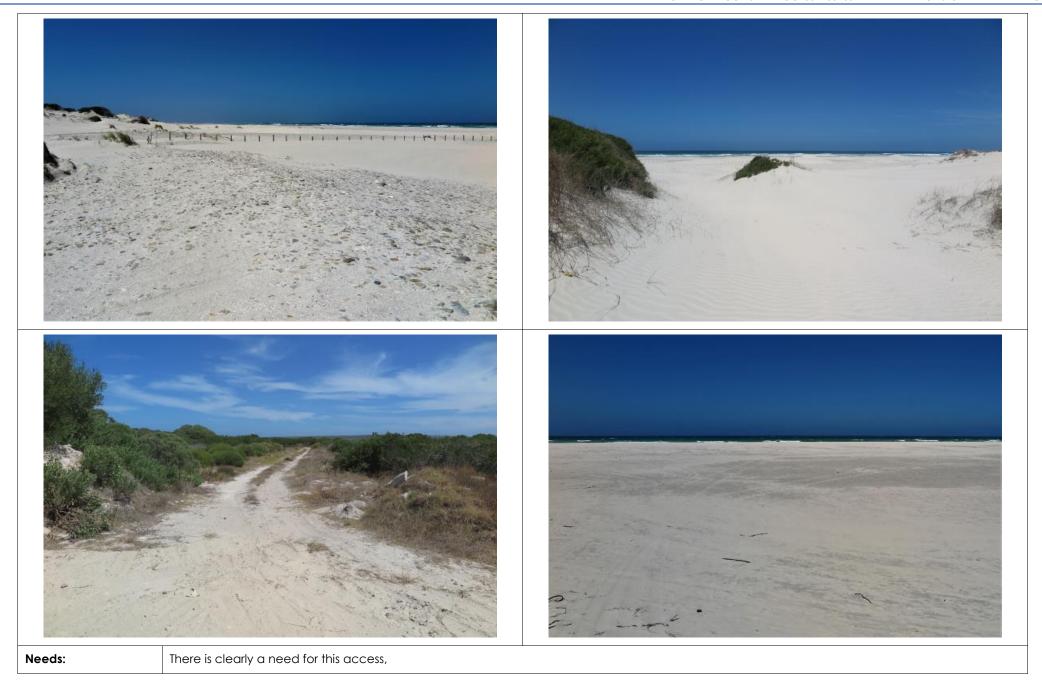
Town/area	Struisbaai
Site Ref:	Struis 09
Description:	Well maintained sand road through dune vegetation culminating in a small turning circle/ parking area for approximately two cars. The track extends over the dunes to the beach where a wooden pole "fence" prevents unrestricted lateral vehicle access. Numerous vehicle tracks suggest frequent use.
Facilities provided:	Graded sand road and fence on beach. Two informal tracks have been closed off.

There is no access control so there is no policing of the ORVs accessing the beach-many of which may not be permitted

Comment	The "parking area" on the beach is questioned as is the policing of the ORV permits.					
			Priority Action Items			
Conflict	Environmental degradation/ damage	Safety and security	Identified need	Maintenance required	Further investigations required	Illegal activities
						?

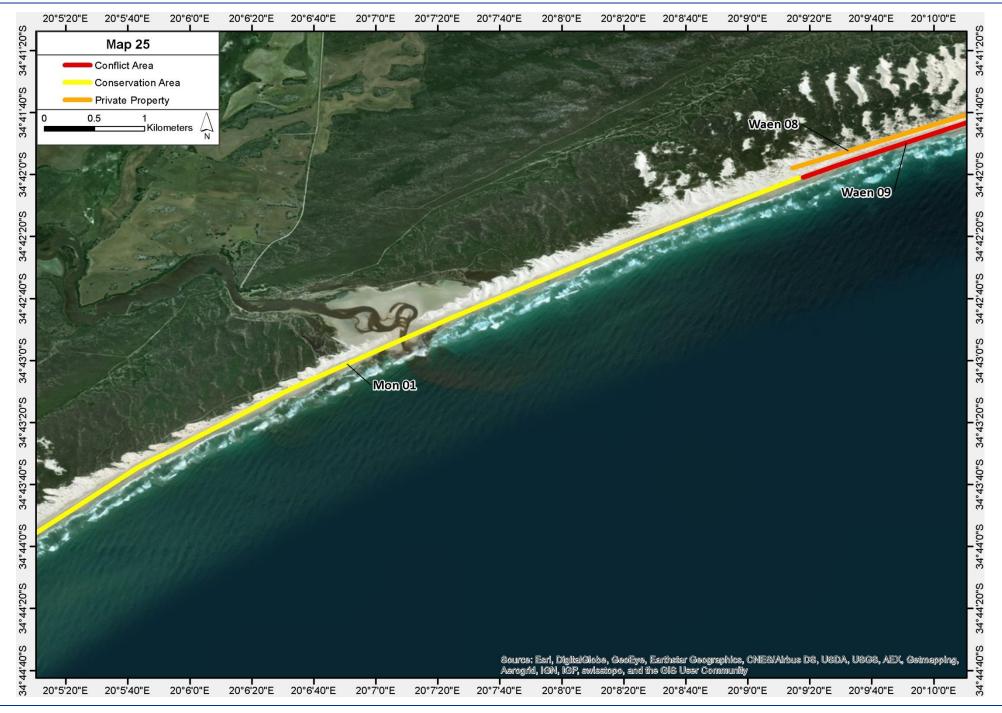
Map 25 shows the remainder of Die Mond conservation area and the start of Waenhuiskrans. Waen 09 is shown as a conflict area in private land. This should be read in conjunction with Waen 06 and 07 in map 26 as they are part of a complete situation.

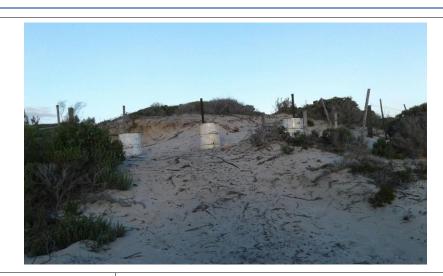
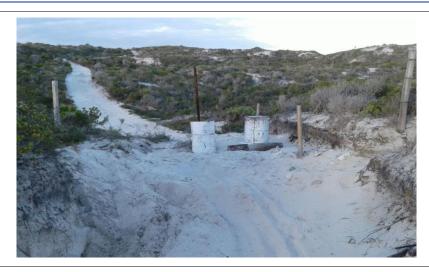
Town/area	Waenhuiskrans				
Site Ref:	Waen 08 and 09				
Description: Private property to the CPP. Access by prior arrangement with land owners only although illegal access is evident.					
Facilities provided:	Nil				
Planned uses catered for:	Nil				
Concerns:	The need for access through this land is exacerbated by the closure of the Cape Nature road in the reserve (Waen 06 and 07). ORVs traverse these properties illegally and the landowners have been served with notices by DEA for "allowing" illegal beach access. There is no management of activities of the visitors if they do gain access and unrestricted driving on the beaches and in the dunes takes place.

Needs:	It is uncertain if the need for access through these private properties would fall away if the Cape Nature Road was re-opened.
Comment	Further investigations need to be undertaken to resolve this conflict.

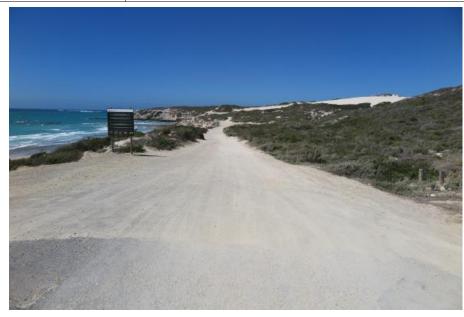
Town/area	Waenhuiskrans
Site Ref:	Waen 06 and 07
Description:	Conservation area managed by Cape Nature. A gravel road runs through the park in a south-westerly direction. This road was historically used by Arniston and Waenhuiskrans residents to access the southern beaches and fishing areas. It has since been closed by Cape Nature, however barriers placed by Cape Nature are frequently illegally removed to permit access for vehicles.
Facilities provided:	Nil
Planned uses catered for:	Conservation only
Concerns:	This is a conflict area in which historic uses have now been denied. If the access road through the park were to be re-opened and managed, it would take the pressure of the dangerous road down the eastern coast to the point.

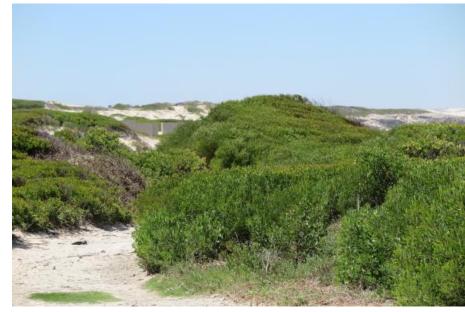
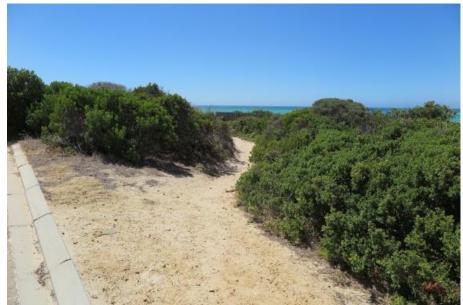
Town/area	Waenhuiskrans				
Site Ref:	Waen 01, 02 and 03				
Private residences abut the CPP but there is ample longshore pedestrian access. Numerous informal private paths through the dune vege have developed but only one formal access point (Waen 02) has been provided					
Facilities provided: A single formal access point					
Planned uses catered for:	Dog walking, viewing, walking				
Concerns:	Numerous informal paths from the private residences through the dune vegetation to the beach have developed. Aerial photographs and visual inspection show erosion occurring as a result to the detriment of the dune vegetation. These need to be restricted in number and size to prevent further damage. The numerous informal paths may not be legal. The Municipality needs to determine their legal status and close them if necessary.

Needs:	The is obviously a need to access but this should be more formalised Maintenance is required as is further investigation into access needs.					
	Priority Action Items					
Conflict	Environmental degradation/ damage	Safety and security	Identified need	Maintenance required	Further investigations required	Illegal activities
	X			X	X	?

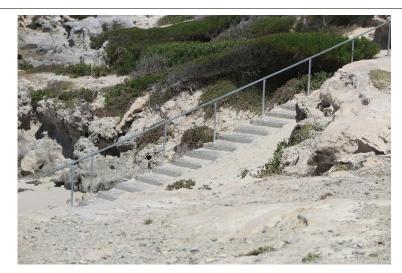
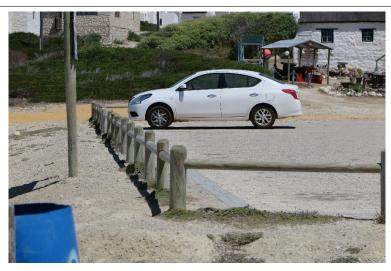
Town/area	Arniston					
Site Ref:	Arn 02					
Description:	Gravel road to parking and picnic area with braai facilities, ablutions, benches and lookout points. Stairs lead down to the beach. Adequate signage					
Facilities provided:	Ablutions, signage, stairs, benches, braai facilities, parking, turning circle, waste bins					
Planned uses catered for:	Swimming, sight-seeing, braai, picnic, fishing					
Concerns:	Numerous informal paths have been made through the dune vegetation to the north. These should be limited in number to prevent dune degradation.

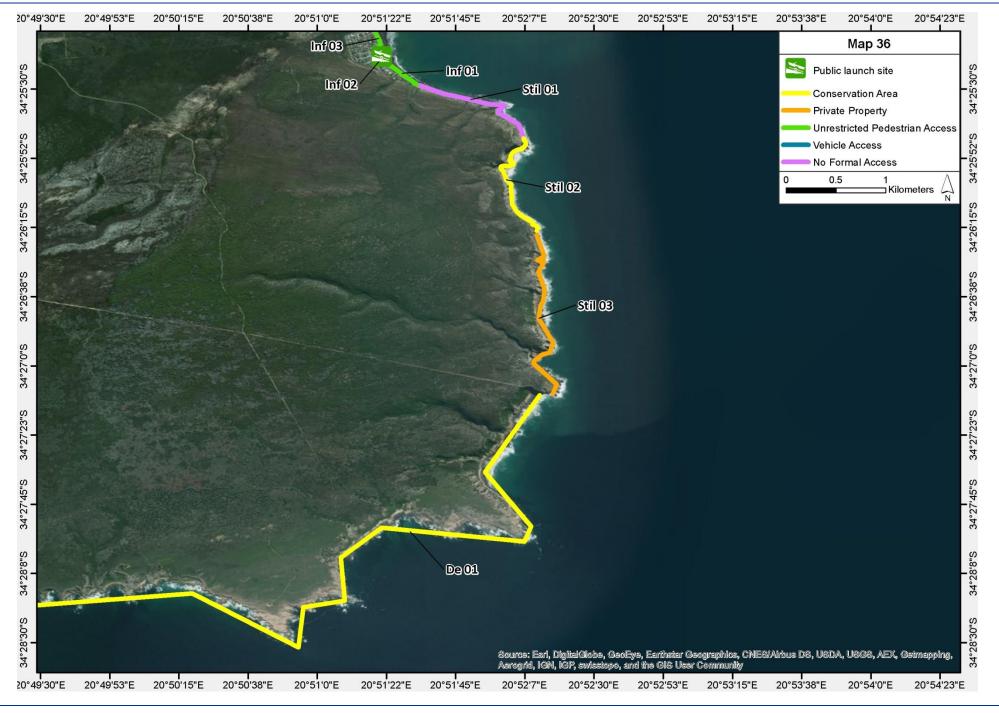
Map 36 shows Stilbaai and most of Cape Infanta. The southern portions of Stilbaai have restricted coastal access as a result of private property and conservation areas.

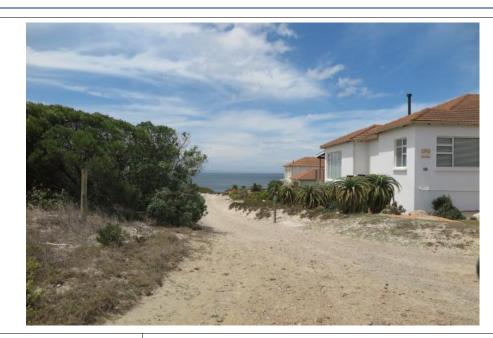
Town/area	Cape Infanta				
Site Ref:	Inf 03				
Description:	Private residences to the CPP. A gravel road for resident's use runs seaward of the properties- there is a gate which can be used to restrict vehicular access. Pedestrian access is not restricted. There are numerous informal paths through the dune vegetation to the beach.				
Facilities provided:	Gravel road and gate				
Planned uses catered for:	Walking, viewing, fishing				
Concerns:	The road in front of the houses does not have a name and may not be a formally declared road and may therefore be illegal. However it is maintained and provides pedestrian access and limited vehicular access to the CPP.				
	The numerous informal paths through the dune vegetation are of concern. Consideration should be given to formalising one or two to prevent dune degradation.

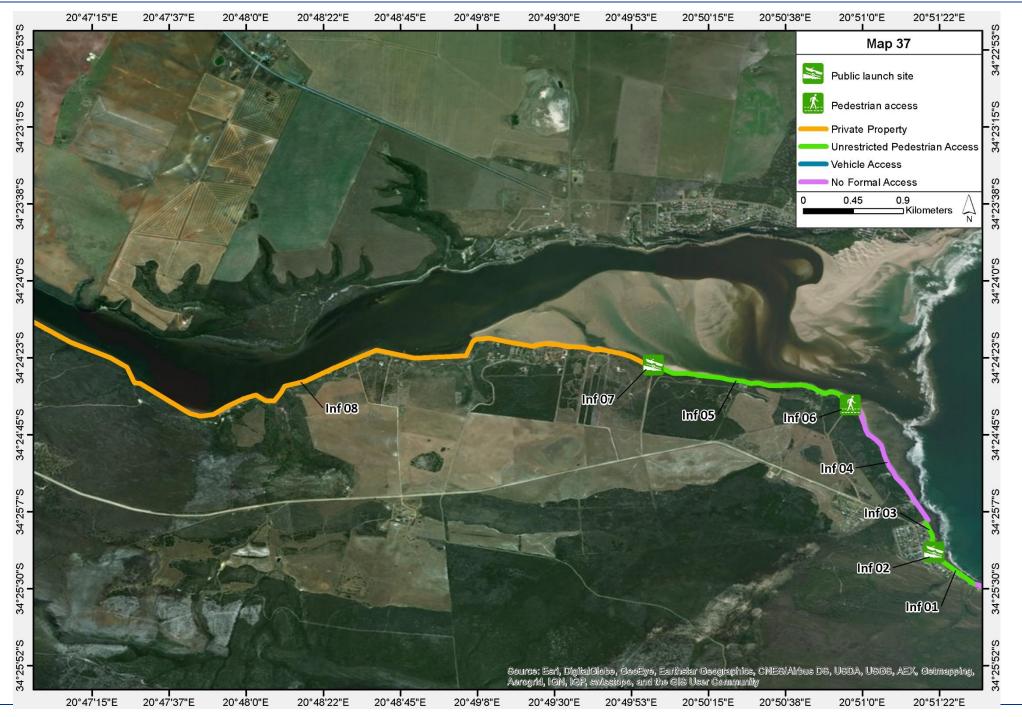
Map 37 shows the two formal launch points north of Cape Infanta as well as the boardwalk at Inf 06.

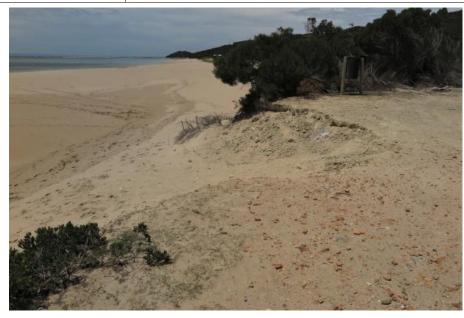
Town/area	Cape Infanta
Site Ref:	Inf 06
Description:	A single gravel road leads from the main road to a gravel parking area with ablutions and a wooden lookout point and stairway to the beach
Facilities provided:	Ablutions, signage, fencing to prevent lateral expansion of the parking area, bins, wooden viewing platform, wooden stairs to the beach
Planned uses catered for:	Viewing/ viewing, fishing
Concerns:	Some erosion on either side of the stairway which needs to be monitored
